Coronado Watershed Park Management Plan

May 2023

Southern Sandoval County Arroyo Flood Control Authority (SSCAFCA)

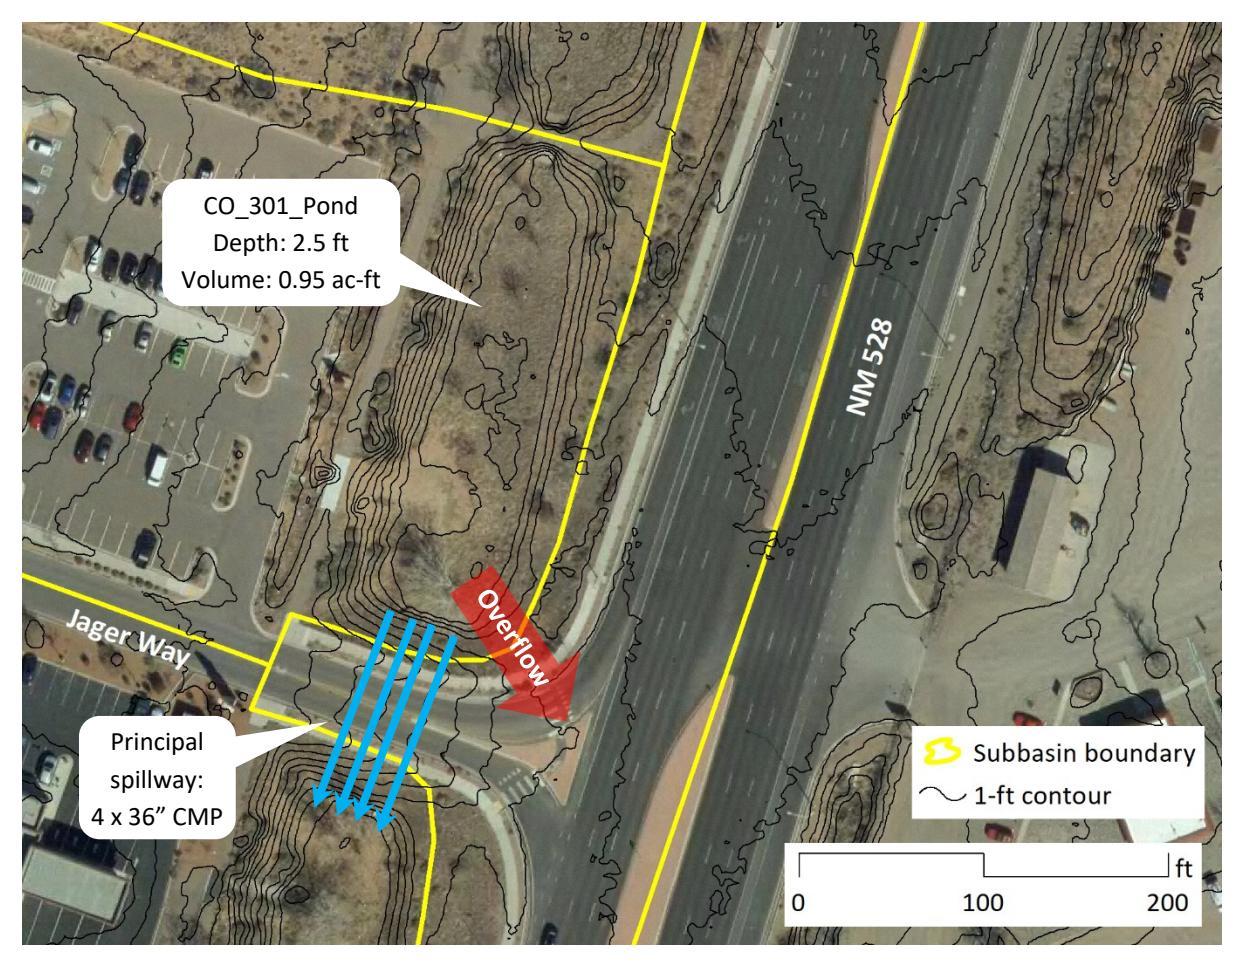
CO_301_Pond, at the northwest corner of NM 528 and Jager Way, is at capacity under existing conditions and exceeds capacity for developed conditions. The pond does not have an emergency spillway, and runoff in excess of the pond capacity would spill over the embankment in the south-east corner and onto NM 528 (see Figure 2.6). This is considered a low concern under existing conditions (pond at capacity), but a high concern for developed conditions because runoff spilling onto NM 528 is expected to significantly impact traffic. CO_301_Pond is owned and operated by the City of Rio Rancho.

Figure 2.6: Map of CO_301_Pond adjacent to NM 528 showing 1-ft elevation contours.

Due to the capacity constraints identified in this report and potential impacts for NM 528, it is recommended that the storage volume of CO_301_Pond be increased. This could be accomplished by raising the embankment in the south-east corner of the pond by approximately 2 feet.

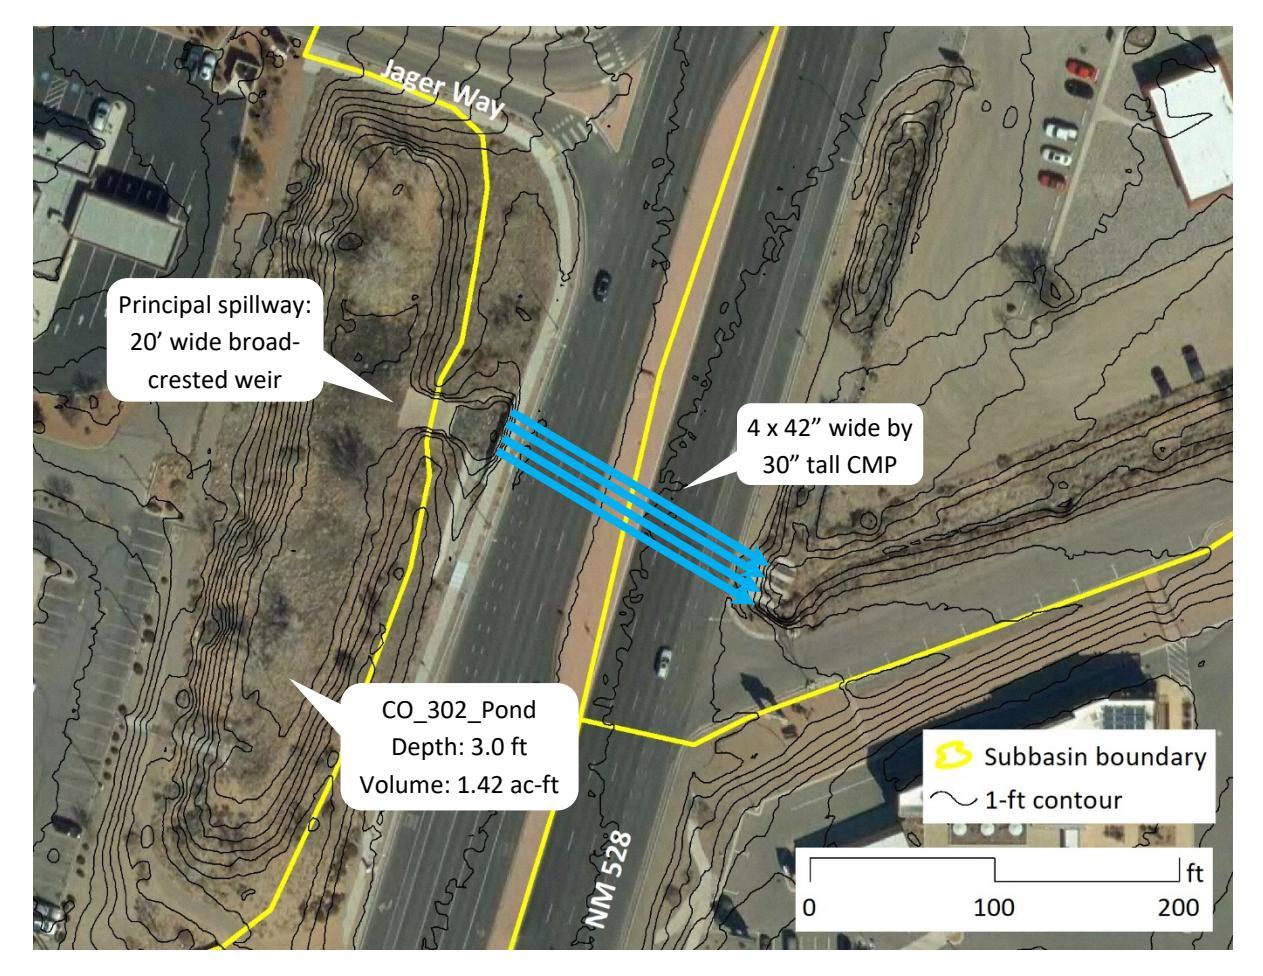
The principal spillway of CO_302_Pond at the southwest corner of NM 528 and Jager Way is a 20-ft wide broad-crested concrete weir (see Figure 2.7). Once runoff leaves the pond, it flows through a set of four elliptical (42 in wide by 30 in tall) corrugated metal pipes under NM 528. During low flows, the broad crested weir governs outflow from the pond. When depths in the pond exceed approximately 2.0 ft, outflow is dictated by the culvert crossing. At a ponding depth of approximately 2.5 ft, water will spill onto the roadway. Under existing conditions, ponding depth is estimated at 2.1 ft. The ponding depth of 2.5 ft under developed conditions is considered a high concern because runoff spilling onto NM 528 is expected to significantly impact traffic. CO_302_Pond is owned and operated by the City of Rio Rancho.

Figure 2.7: Map of CO_302_Pond adjacent to NM 528 showing 1-ft elevation contours.

Given the capacity constraints under developed conditions, and the possibility of runoff ponding in NM 528, it is recommended that CO_302_Pond be modified to decrease peak discharge during the 100-year storm. This could be accomplished by modification of the principal spillway in conjunction with a slight increase in pond storage volume.

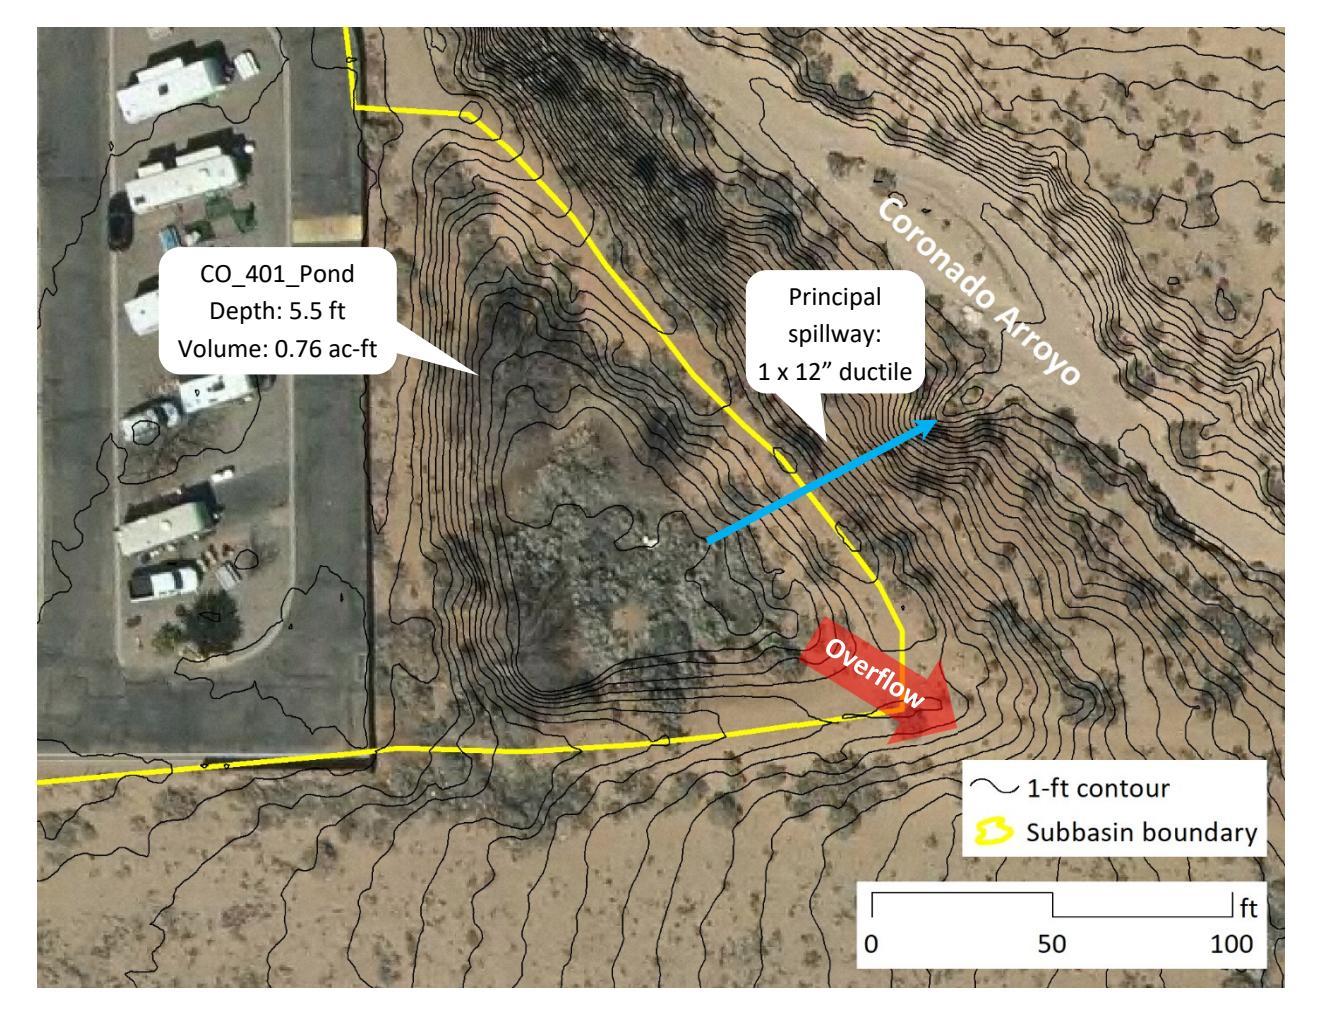
- The interior of the pond is overgrown with vegetation, and the inlet of the principal spillway could not be located. It is possible that the pipe inlet is partially or entirely clogged.
- Even if the principal spillway functions properly, the pond does not have sufficient capacity to safely detain the 100-year runoff volume under both existing and developed conditions.
- No emergency spillway exists. Flow over the unprotected pond embankment would likely lead to rapid failure of the embankment, particularly due to the steep slope downstream. This may lead to flooding and sediment deposition in the downstream system.

CO_401_Pond is privately owned and is considered a high concern both under existing and developed conditions.

Figure 2.8: Map of CO_401_Pond adjacent to the Coronado Arroyo showing 1-ft elevation contours.

Given the concerns relating to CO_401_Pond discussed in section 2.12.5 above, the following modifications are recommended:

- Re-design of the principal spillway, including an inlet structure resistant to clogging; ideally, this should coincide with proposed channel improvements to determine the best location and elevation for the point of discharge into the Coronado Arroyo.
- Construction of an armored emergency spillway to safely convey any overflow into the Coronado Arroyo and reduce the risk of catastrophic pond failure.
- Clarification of ownership and maintenance responsibilities.

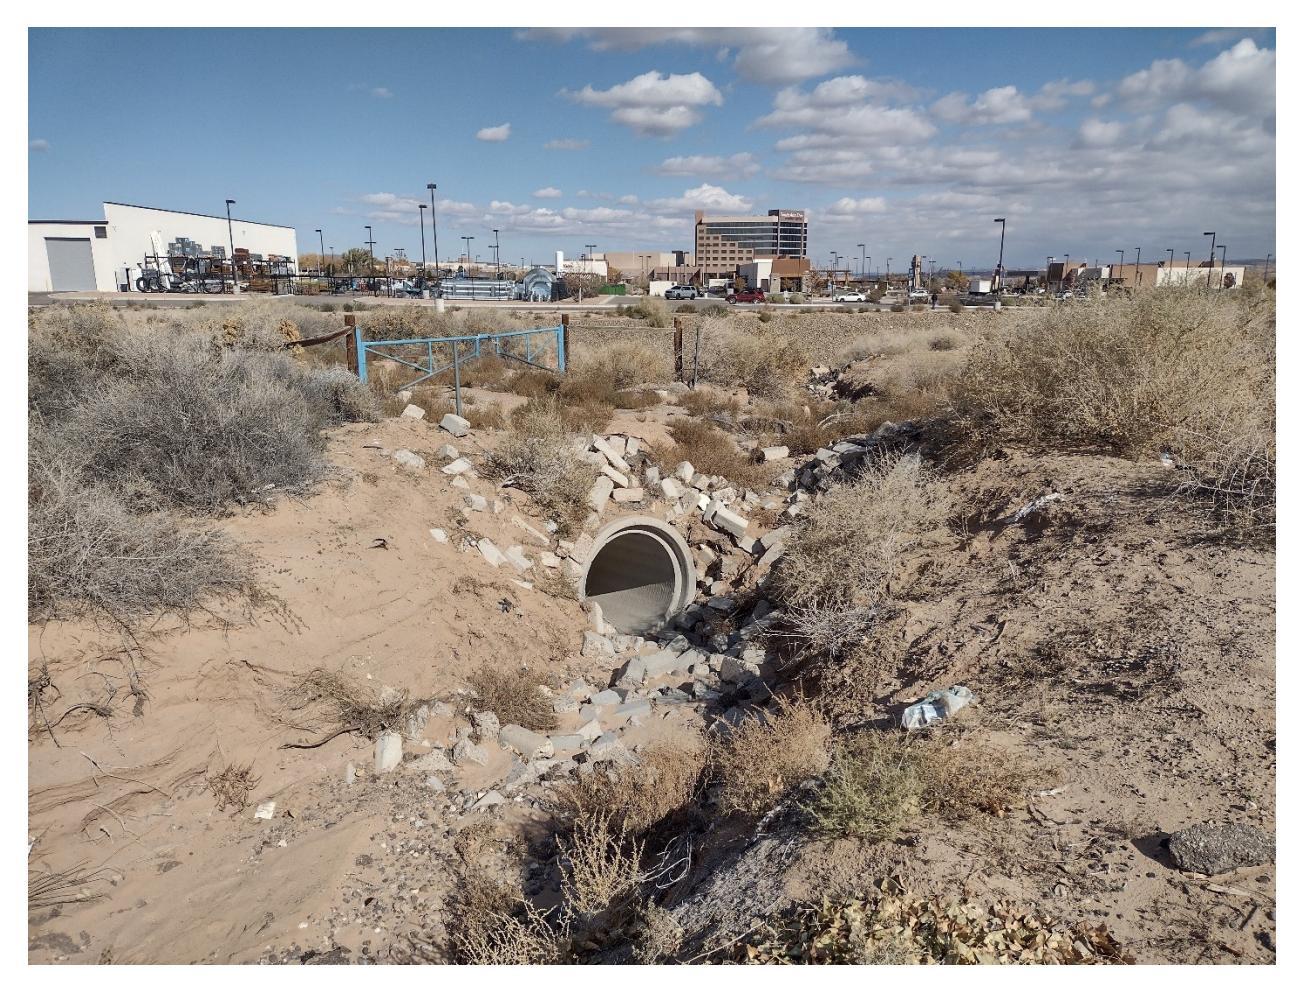
Figure 2.9: Picture of the storm drain inlet at the end of the Gabby Lane Channel, just before the confluence with the Coronado Arroyo. The inlet frequently clogs, leading to flow spilling over the channel sides and creating a head cut in the steep bank of the Coronado Arroyo.

area residents confirm that during storm events, the storm drain inlet (see Figure 2.9) frequently clogs with debris and sediment. This leads to runoff spilling out of the channel, affecting adjacent properties, and generating a head cut in the steep bank of the Coronado Arroyo (see Figure 2.10).

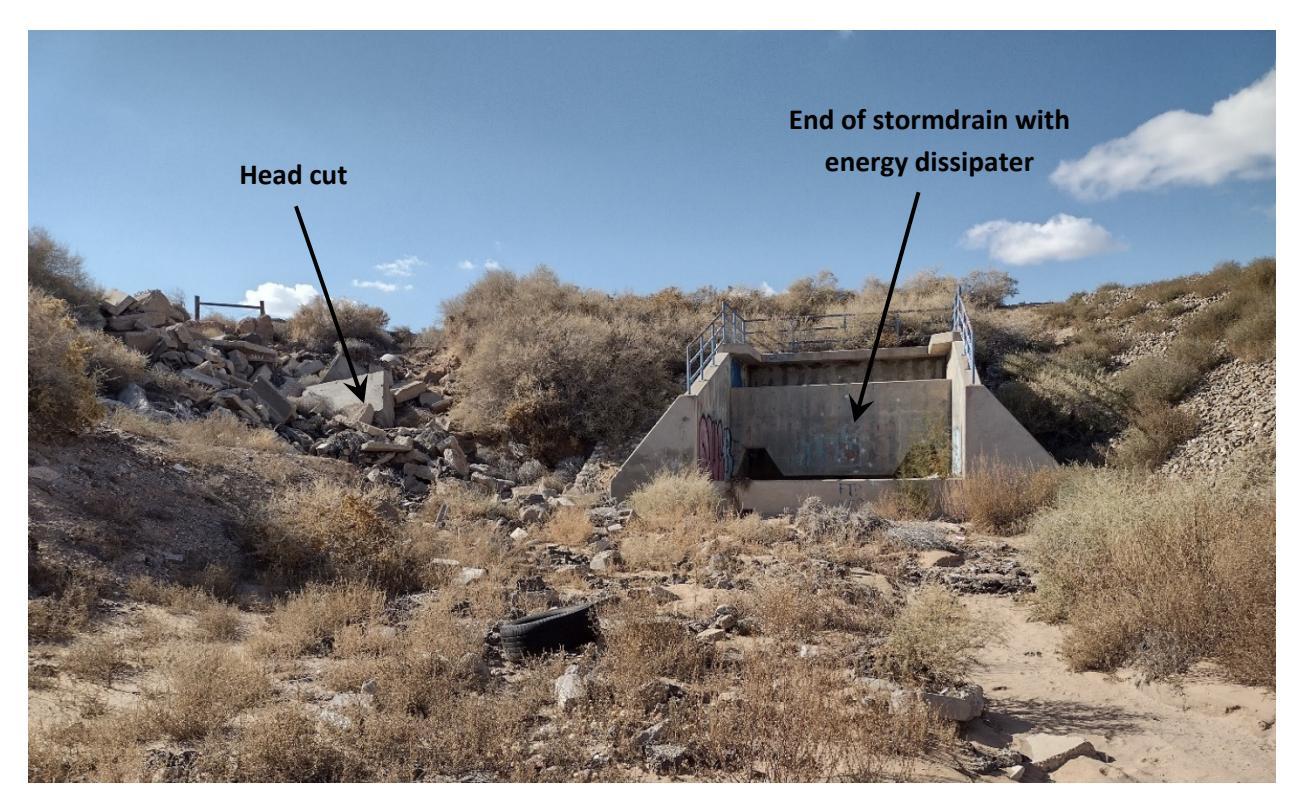
- The channel is overgrown with vegetation and likely has insufficient capacity to safely convey the 100-year peak discharge.
- Near the end of the channel adjacent to the Coronado Arroyo, runoff in the channel is intercepted by a 4-foot diameter reinforced concrete storm drain (see Figure 2.9). This pipe connects to the storm drain trunkline that discharges into the Coronado Arroyo at the upstream end of subbasin CO_103 (see Figure 2.10). Eyewitness statements from

Figure 2.10: Photo of the energy dissipater at the end of the stormdrain that starts at the outlet of CO_101_Pond (right), and head cut caused by flow from the Gabby Lane Channel, filled with concrete rubble and trash from illegal dumping.

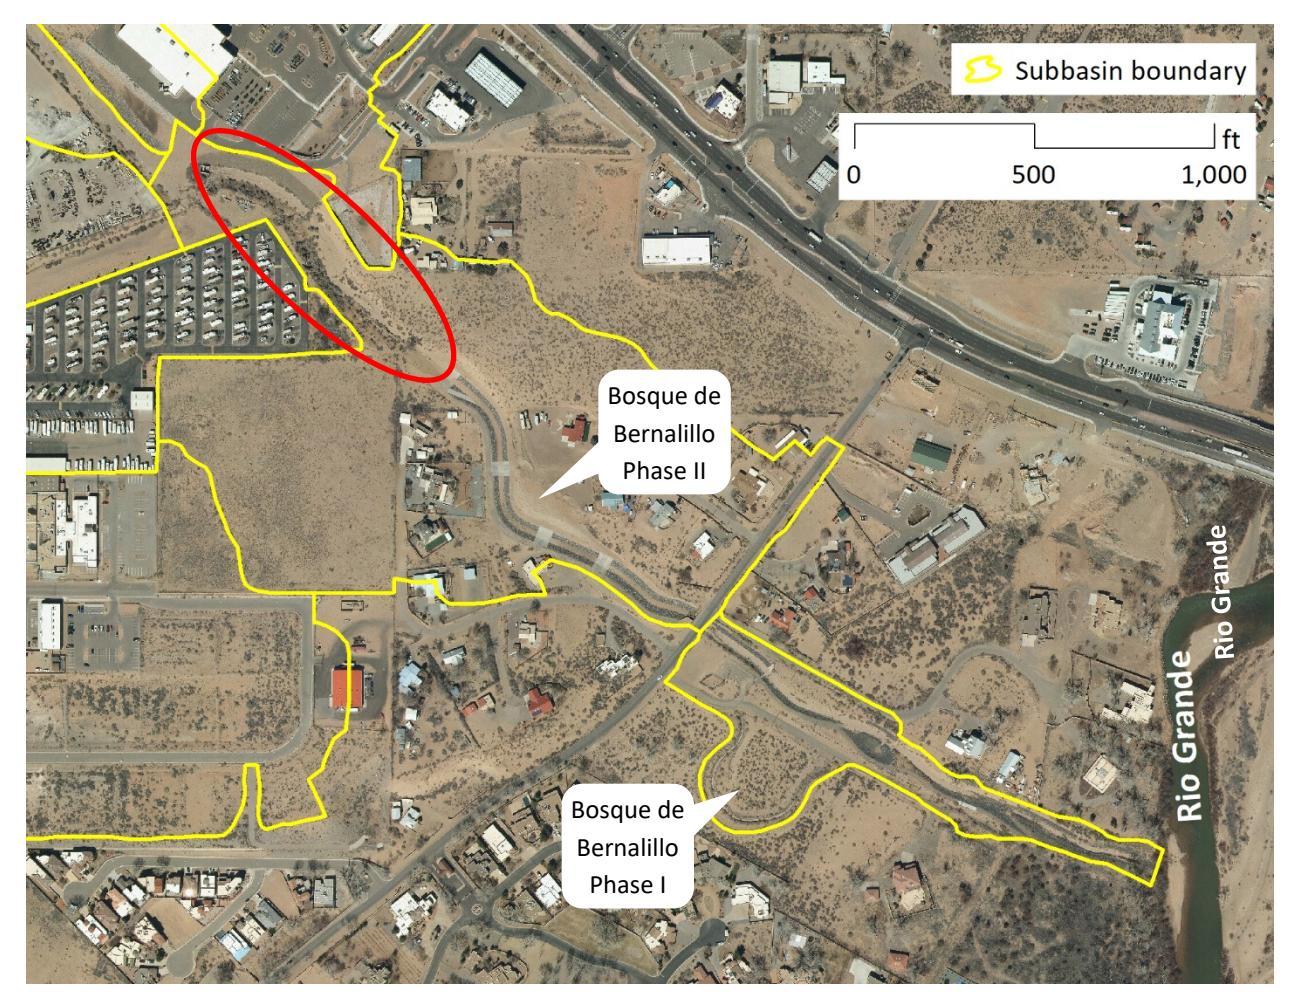
Upstream of the Bosque de Bernalillo Phase II project, a short segment of the Coronado Arroyo – approximately 850 ft in length – remains unimproved (see Figure 3.3). Vertical stability of the Arroyo in this reach is compromised by the discharge of relatively sediment-deprived stormwater from urbanized basins upstream. Continued lateral migration may threaten existing infrastructure to the north and south. Channel improvements including bank protection and grade control structures should therefore be implemented in this reach. Additionally, this segment of the Coronado Arroyo has experienced decades of illegal dumping and is littered with construction debris such as broken concrete (including rebar), steel and concrete pipe segments, along with a host of other assorted urban trash. For aesthetic, environmental and safety reasons, trash cleanup and subsequent fencing should be seen as a priority. The land is owned by the City of Rio Rancho, with a drainage easement held by SSCAFCA.

Figure 3.3: Aerial image of the lower Coronado watershed with subbasin boundaries indicated in yellow. Outlined in red is the portion of the arroyo requiring lateral and vertical stabilization.

In December 2021, the SSCAFCA Board of Directors adopted a resolution to include conservation of natural arroyo beds as corridors of infiltration and groundwater recharge as an integral component of flood control systems owned and operated by the agency (SSCAFCA, 2021). The resolution is based on research showing that focused infiltration in ephemeral channels in a crucial source of groundwater recharge in many dryland watersheds (Goodrich et al., 2018; Shanafield and Cook, 2014; Constantz et al., 2002; Coes and Pool, 2005). Major arroyos within SSCAFCA's jurisdiction likely provide this important ecosystem service (Schoener, 2022) and should therefore be protected wherever feasible. Preservation of ephemeral channels requires foresight and planning. In urbanizing areas, land is a finite and valuable resource. If seen as mere conduits for runoff, ephemeral streams will likely be transformed into concrete channels or pipes, the hydraulically most "efficient" means for moving water downstream while occupying the smallest possible footprint. Strategies for preserving focused infiltration in ephemeral channels include designation of a buffer zone to allow space for lateral migration. In cases where existing infrastructure is already encroaching, strategic use of bank armoring and grade control structures to limit lateral and vertical movement is preferrable to channel lining. In the Coronado watershed, the Bosque de Bernalillo Phase I and II projects were designed to preserve natural, permeable channel beds by using bank armoring and grade control structures to stabilize the channel vertically and laterally. It is recommended that improvements for the remaining, unimproved segment of the arroyo (see Figure 3.3) be designed in a similar manner.

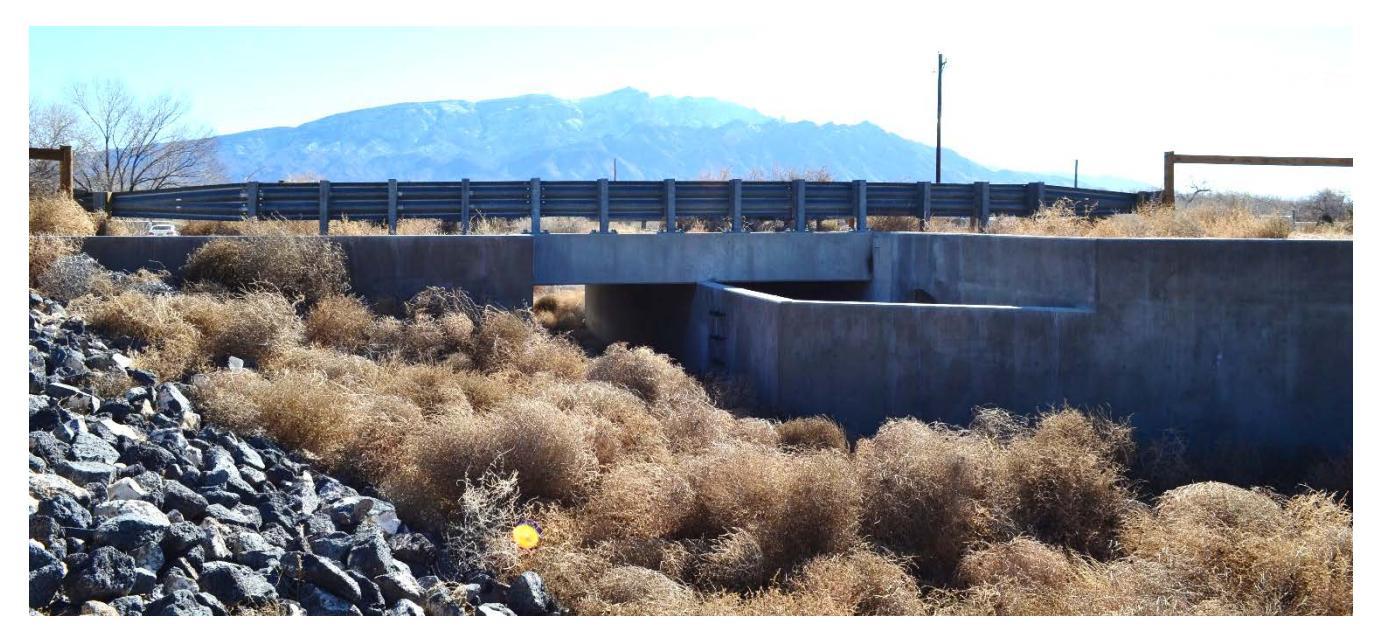
CO_03, upstream with a flood of tumbleweeds. A concrete wall blocks upstream flows from entering the cell on the right.

Estimated maximum flow through the left culvert is 440 cfs. This exceeds the developed conditions peak discharge of approximately 447 cfs at this location. However, the barrier blocking the right CBC cell is open at the top and would allow flow to enter the right CBC barrel if flow depth at the upstream end exceeded 6 ft. Using the broad crested weir equation to estimate flow over the wall, assuming a coefficient C = 3.2, length L = 21.5 ft, and head H = 2.0 ft:

The total capacity of the structure is therefore estimated at 635 cfs, sufficient to safely convey the developed conditions 100-year peak flow.
