Southern Sandoval County Arroyo Flood Control Authority

RE: 2022 Annual Report, NPDES Permit No. NMR04A001

2022 Annual Report

Reporting Period – July 1, 2021 – June 30, 2022

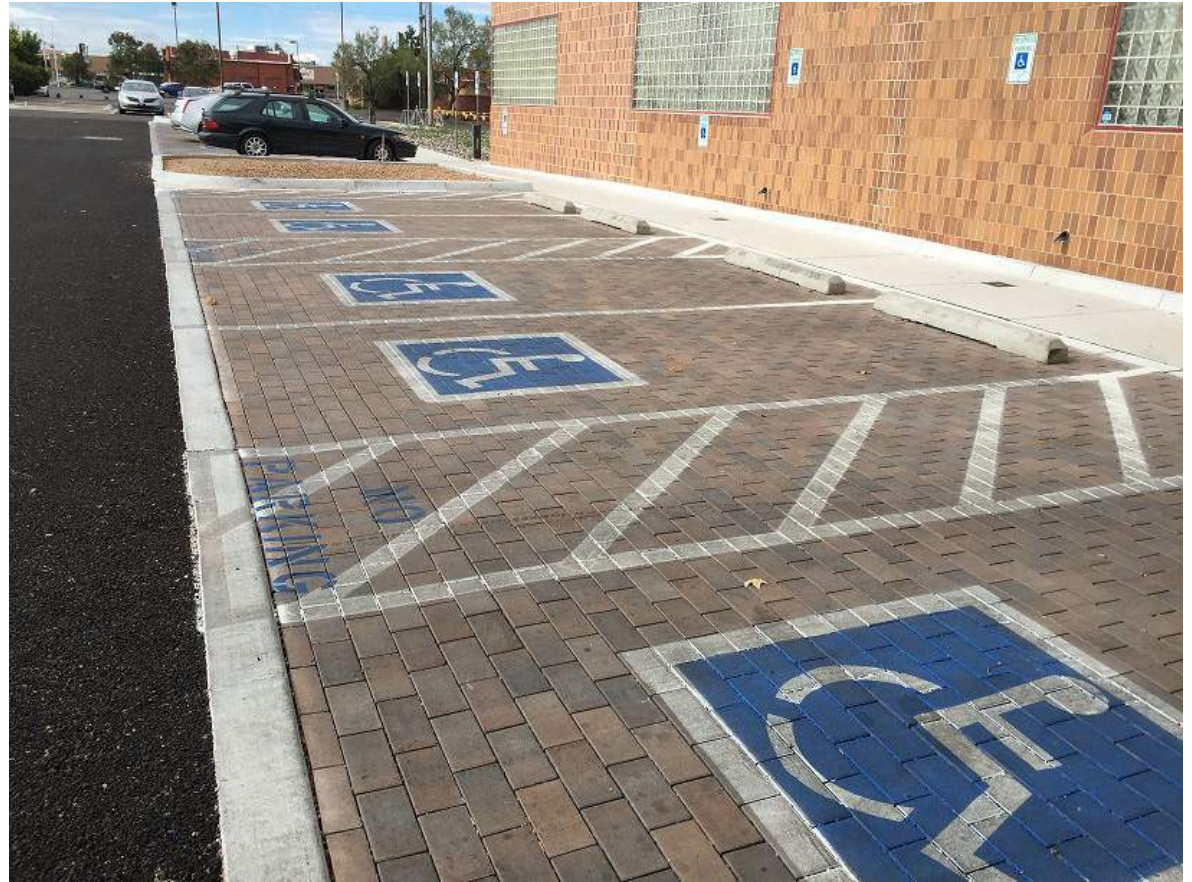
Wheelchair accessible permeable pavement

Regular inspection of permeable pavers is needed to make sure they remain level with a smooth, ensuring compliance with the Americans with Disabilities Act (ADA) specifications.

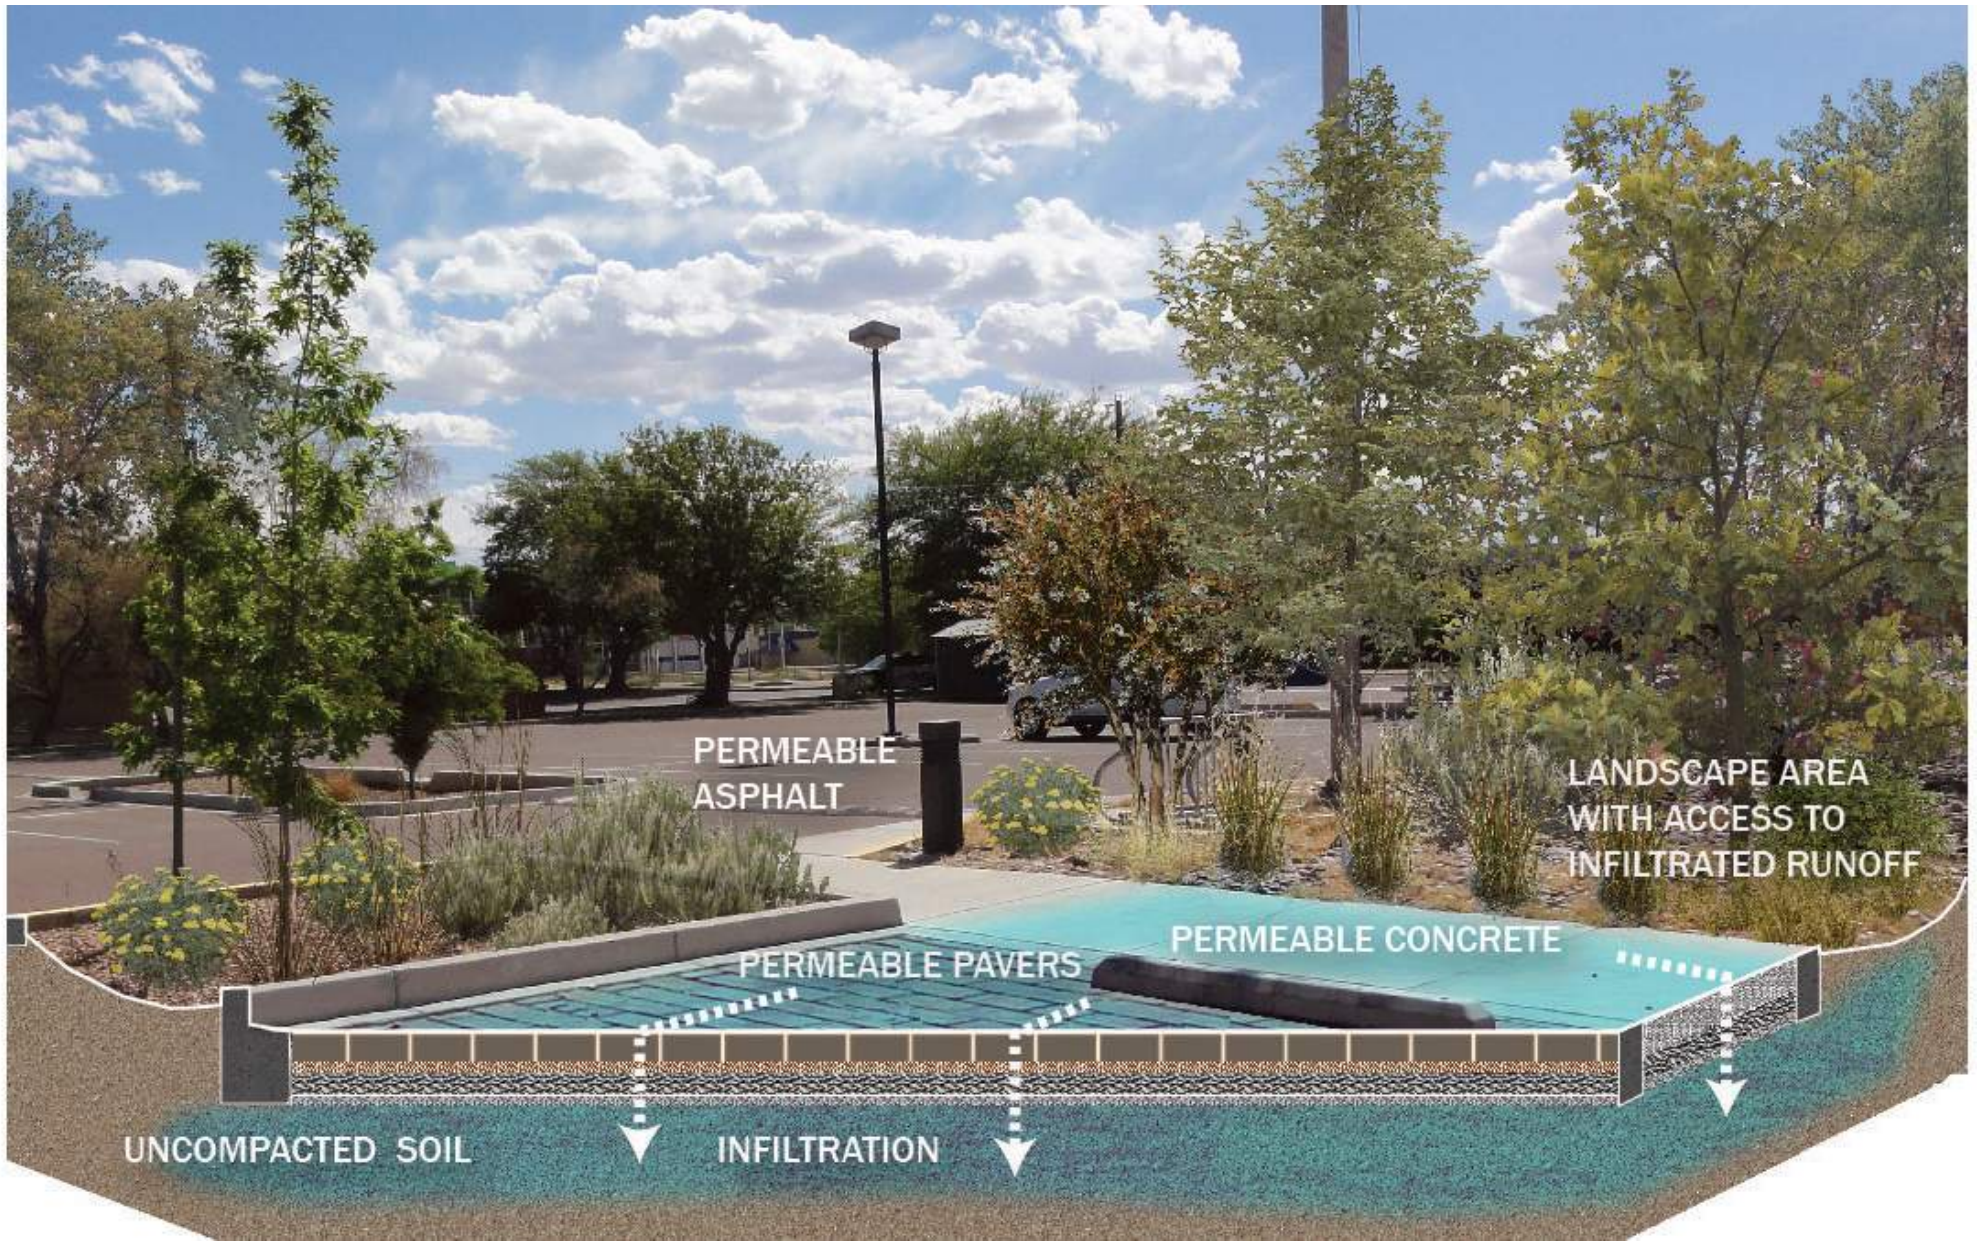
System with multiple permeable pavement types

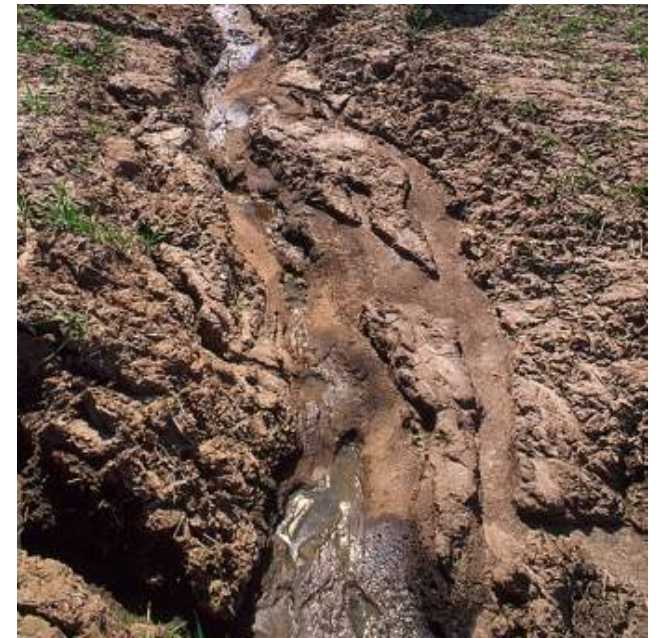
Signs of soil erosion

- ☛ Fill eroded areas with soil material similar to the existing material in place.
- ☛ Grade filled material with a rake, hoe, or other hand tool so that it matches the grade of the surfaces around it.
- ☛ If planting seeds, use an appropriate native seed mix.
- ☛ If erosion is happening due to a lot of water entering the basin too fast, consider installing a check dam, Zuni bowl, erosion blanket, or rip/rap. This will help slow the water down and minimize the amount of sediment washed into the bottom of the basin, which can cause clogging and additional maintenance.

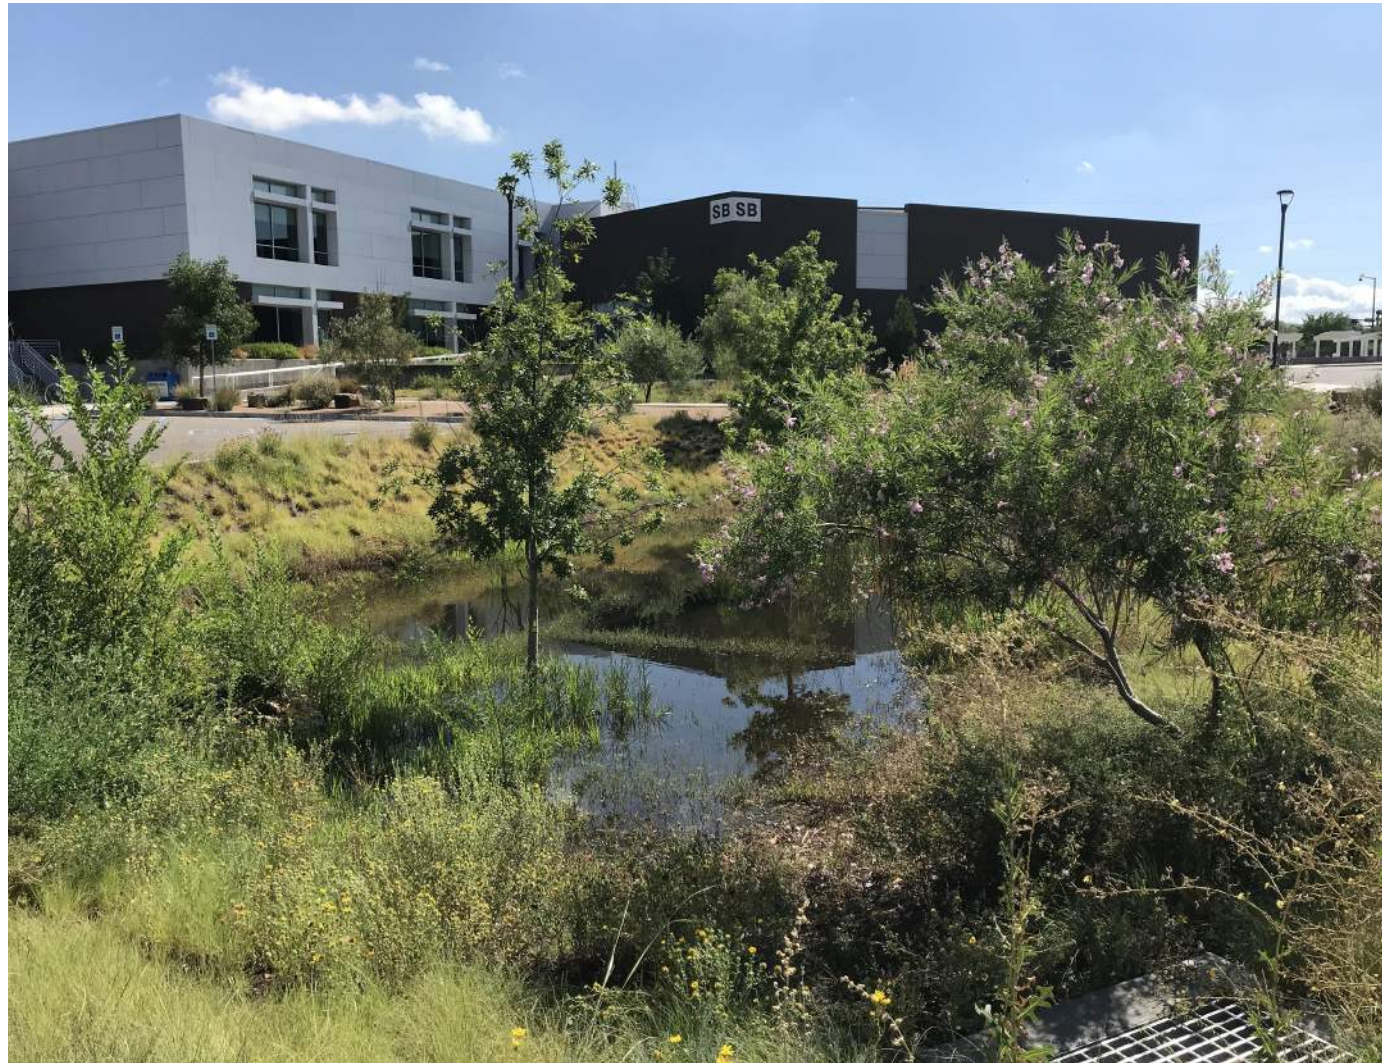
Runoff captured in stormwater harvesting basin at CNM

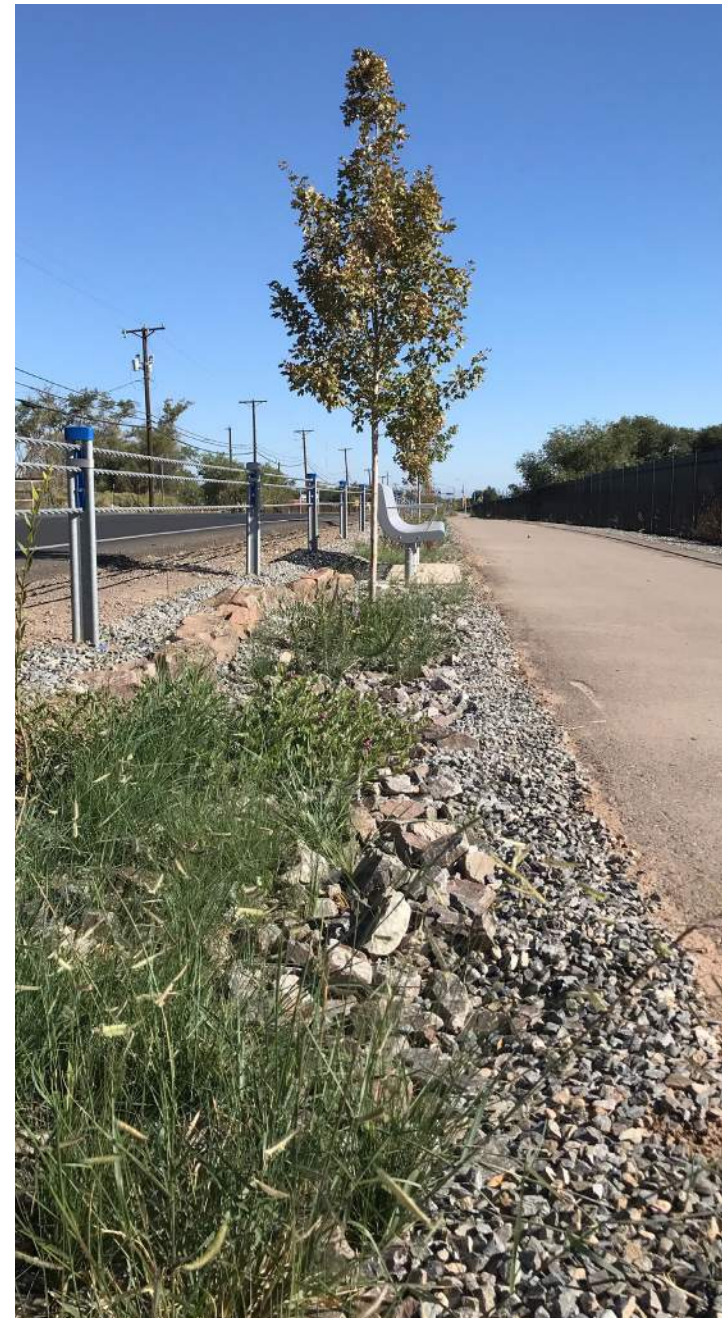
Bioswale along Second St, Mountain View Neighborhood, South Valley, Albuquerque

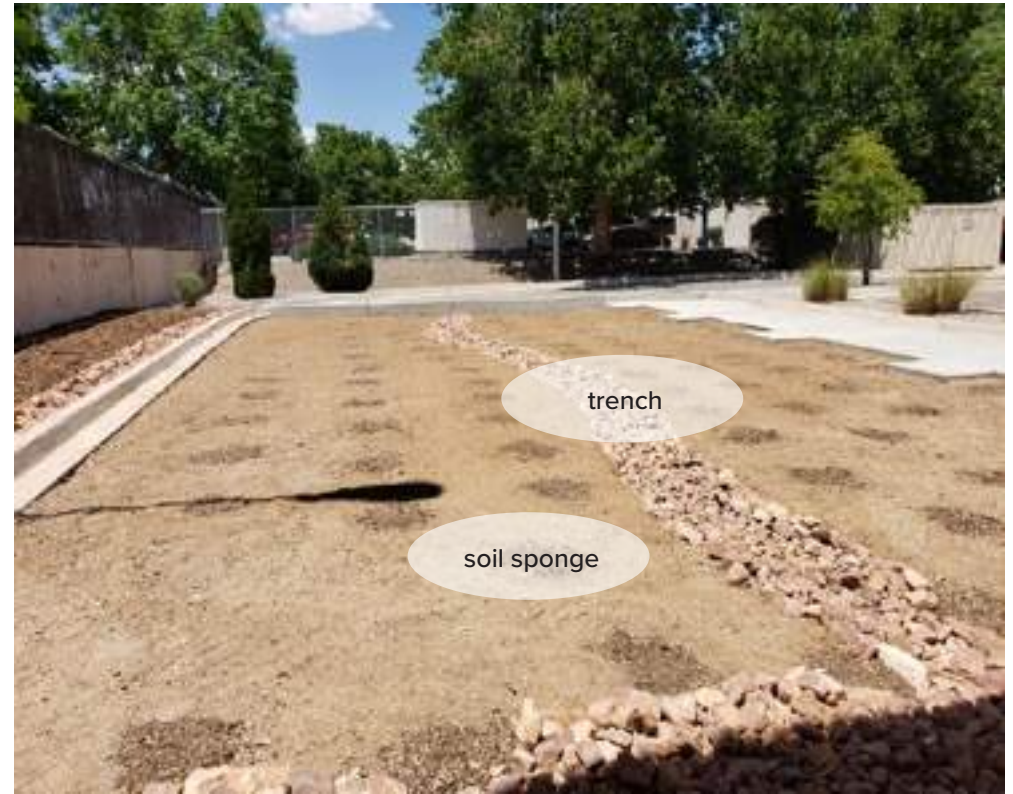
Urban agriculture infiltration conveyance including a conveyance trench and soil sponges.

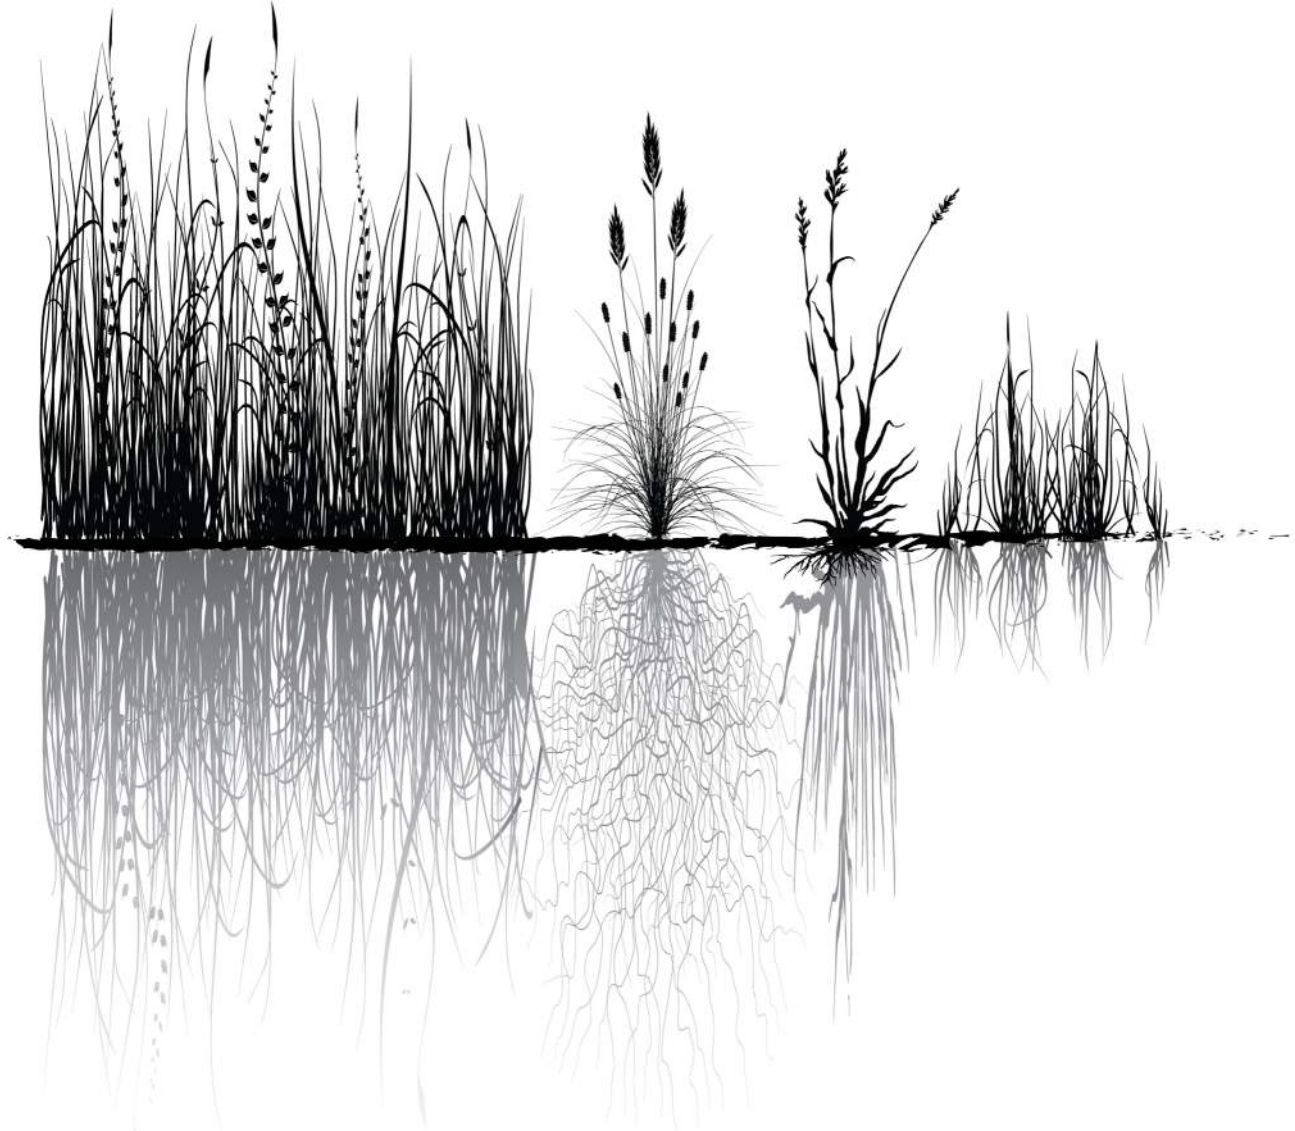
Native Plant Roots Strengthen and Stabilize the Soil

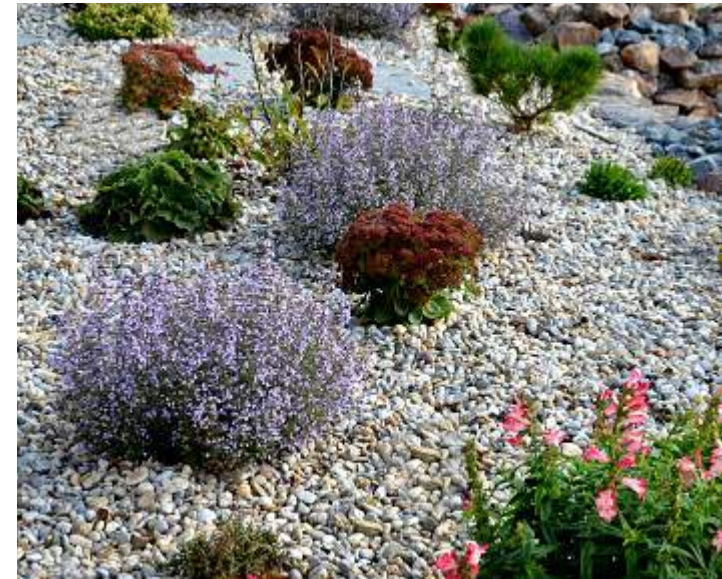
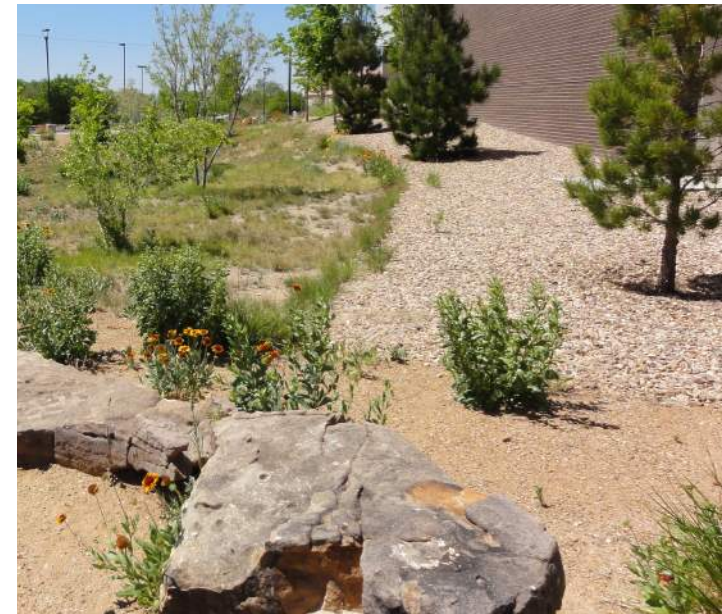
TOP: Native mulch
BOTTOM: Forest floor mulch
Photos from Soilutions
