# WILLOW CREEKWATERSHED PARK MANAGEMENT PLAN

# Southern Sandoval County Arroyo Flood Control Authority

DRAFT WILLOW CREEK
WATERSHED PARK MANAGEMENT PLAN
(WCWMP)

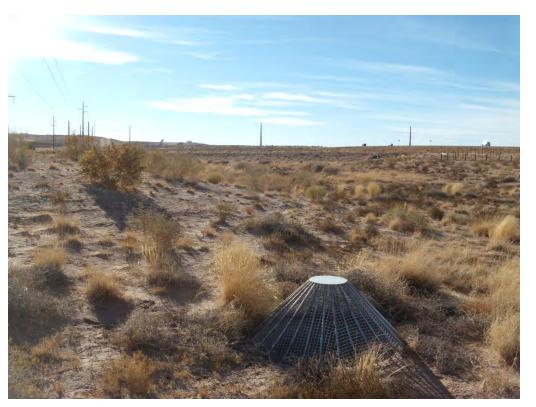
Photo 1: Pond # 13 (WC\_01P, capacity ≈ 3 AF), looking west from the outlet.

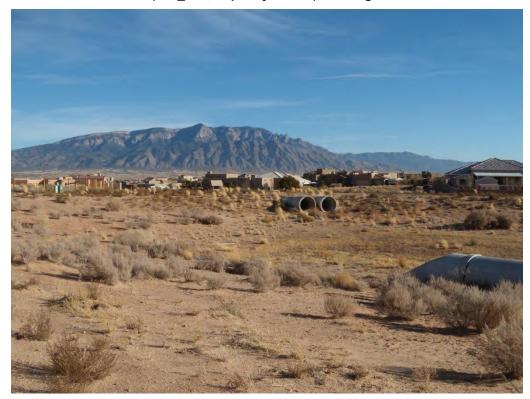
Photo 2: Pond # 6 (WC\_05P, capacity ≈ 3 AF), with the outlet visible in the background.

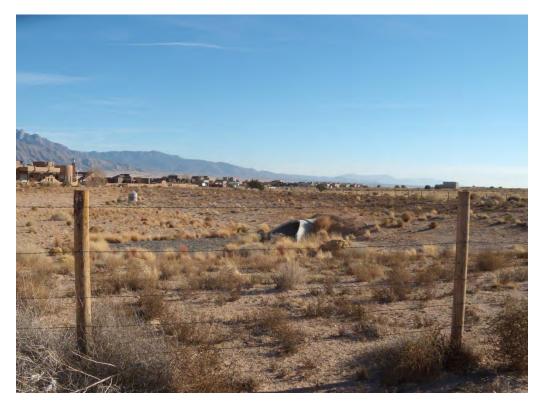
Photo 3: Pond # 2 (WC\_05P, capacity ≈ 9 AF)

- Under EXISTING and DEVEX conditions, WC\_05P (SAD 6 Pond # 2, see map tile 1 in Appendix B) acts as a retention pond; the proposed improvements to the outlet structure would allow the pond to drain completely under ULTIMATE conditions, thus increasing the runoff volume reaching analysis points downstream of the pond.

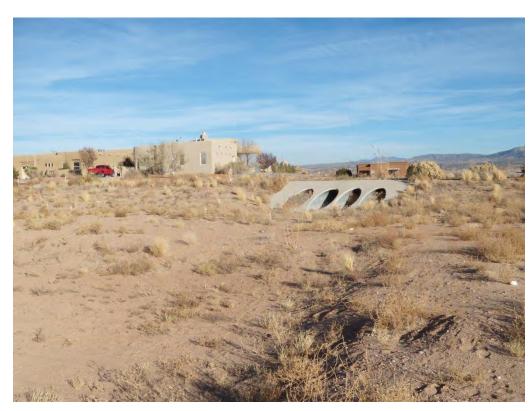
Photo 4: Pond # 10 (WC\_03P, capacity ≈ 4 AF); culvert crossing serves as outlet structure.

- o Pond # 10 (WC\_03P, Photo 4) is part of the SAD 5 drainage improvements (WCRD 03).
  - The Sandoval County Pond (WC\_04P, Photo 5) was constructed in conjunction with development of the Sandoval County Judicial Complex (maintained by the County).

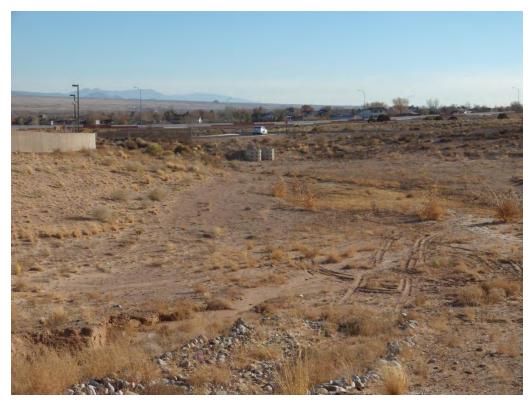
Photo 5: Sandoval County Pond (WC\_04P, capacity ≈ 9 AF), with ported riser outlet structure in the background.

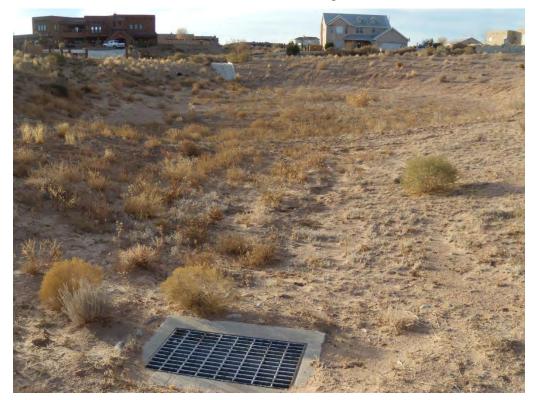
Photo 6: Christopher Pointe Pond (WC\_06P, capacity ≈ 2 AF), with outlet structure in the foreground.

- The pond in Christopher Pointe Subdivision (WC\_06P, Photo 6) is currently the only pond in Basin C.
- Runoff from Basins A, B and C crosses NM 528 and Willow Creek Road through a number of culverts; culvert capacities at NM 528 and Willow Creek Road dictate allowable peak flow rates from the upstream basins (see Table 2 for culvert sizes and estimated capacities).

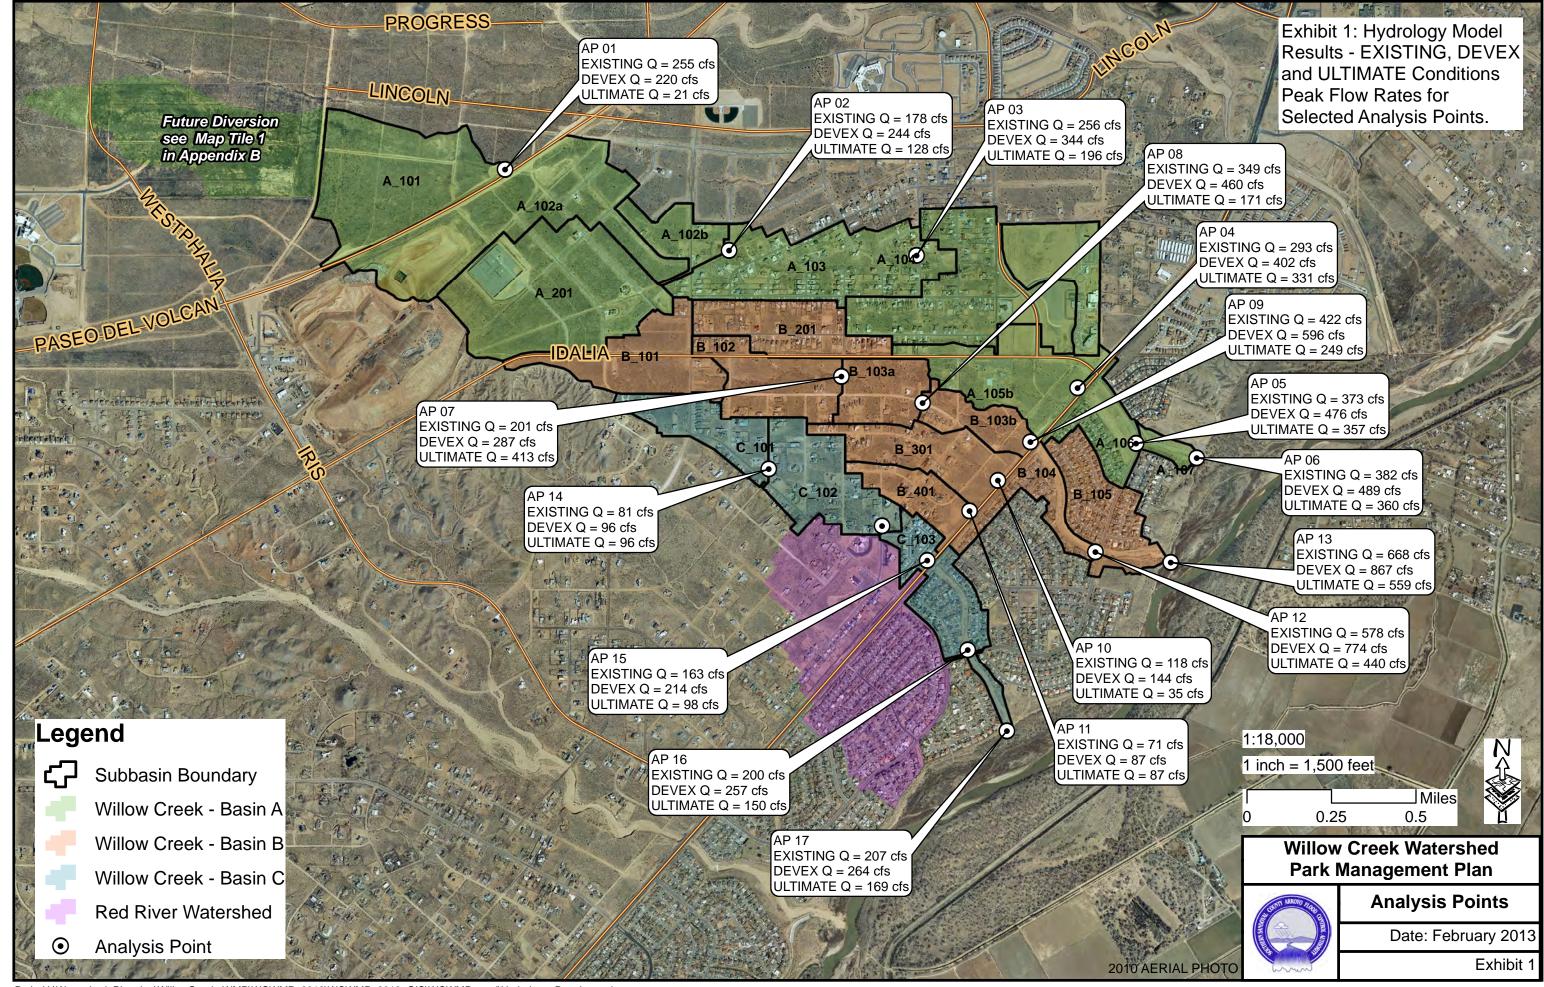
Table 2: Existing, DEVEX and Ultimate Conditions Flow and Capacity Summary for Selected Analysis Points.

Additionally, Table 2 reports significantly higher runoff volumes for analysis points two through six under ULTIMATE conditions as compared to DEVEX conditions. This discrepancy is caused by two factors:

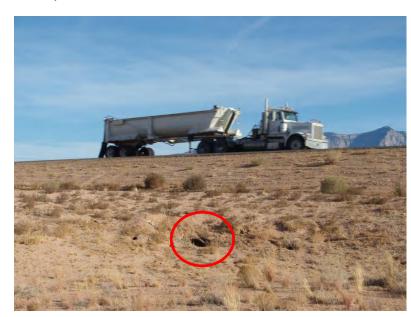
Photo 7: 30" CMP culvert under PDV, partially full of sediment.

The 30" CMP culvert under PDV (Photo 7) has an estimated capacity of 30 cfs. Under EXISTING conditions, the model predicts a peak discharge of 255 cfs from basin A 101 (143 acres).

It is apparent that the existing culvert is insufficient to convey the 100-year flows both under EXISTING and DEVEX conditions. The SAD 6 Drainage Report (WCRD 05) shows a proposed pond just north of Paseo del Volcan (PDV), but that pond has not been constructed. Currently, there is only a small de-silting basin (capacity approximately 1 AF) at the entrance of the culvert.

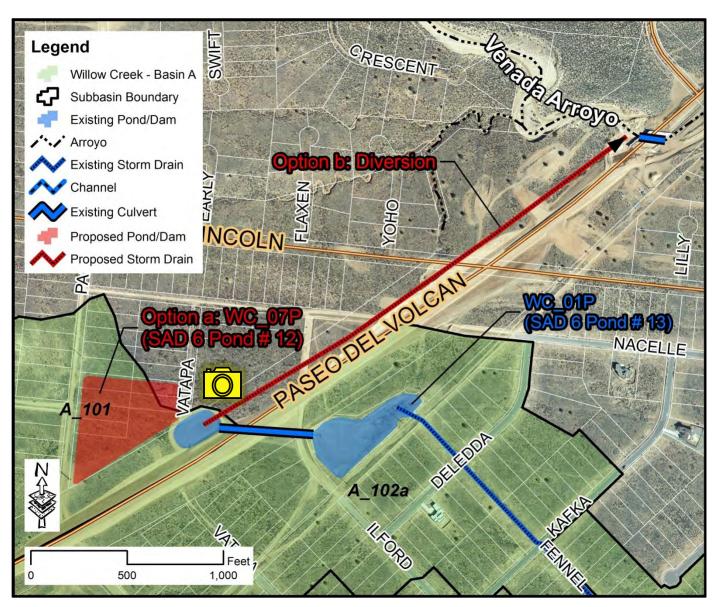
Exhibit 3: Map showing location of proposed pond west of Paseo del Volcan.

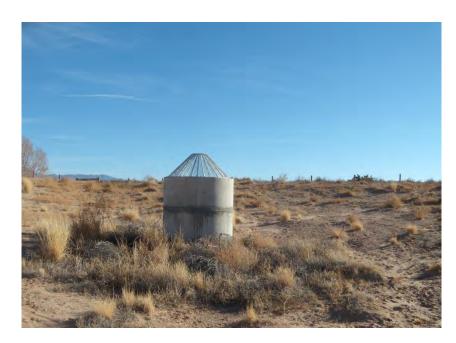
Photo 8: Pond # 2 outlet structure is a concrete riser pipe without ports.

In addition, the outlet structure of Pond #2 (WC\_05P) is a concrete riser pipe without ports (Photo 8). The pond therefore acts as a retention pond until the water surface in the pond reaches the top of the pipe, approximately 7 feet above the pond bottom. According to the SAD 6 report (WCRD 05), the dead storage volume of this pond is estimated at 6.4 AF. This will lead to a stagnant pool of water in the pond after any significant rain event.

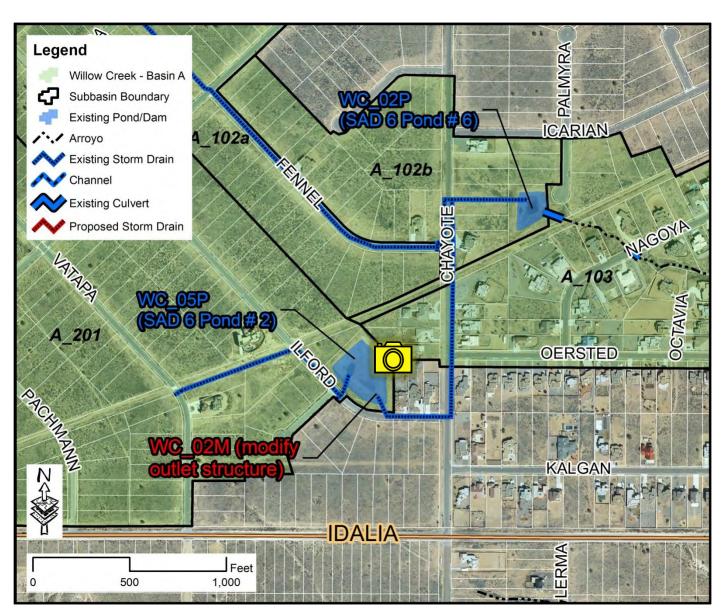
Exhibit 4: Map showing proposed changes to SAD 6 Pond # 2.

Convert outlet structure to ported riser pipe; during high-frequency rainfall events, ports will act as water quality control by filtering out floatables; in addition, ports allow the pond to drain slowly, thereby allowing a portion of the runoff to infiltrate and evaporate, and allowing for sediment and particulate pollutants to settle out in the pond. During the 100-year storm, the top of the stand pipe will act as the principal spillway.

Re-design of the outlet structure, in particular with respect to size and distribution of ports and top elevation of the stand pipe is necessary to optimize water quality and flood control functions of the pond. Modifications to the outlet structure, particularly lowering the top elevation of the standpipe and allowing the pond to start discharging at a lower water surface elevation will solve the capacity problem of the pond. Re-grading of the pond bottom and introduction of ports in the stand pipe will allow the pond to drain completely.

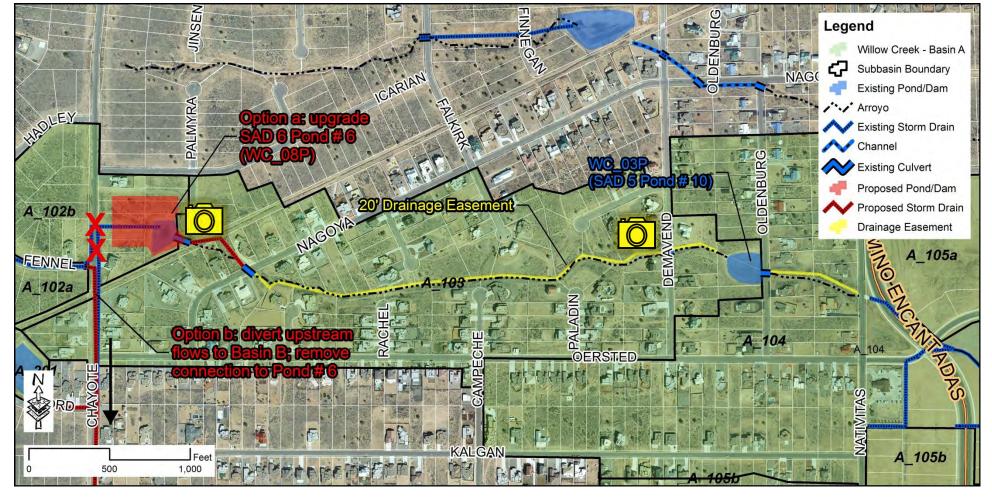
Exhibit 5: Map showing drainage improvement options between Pond # 6 and Camino Encantadas.

Divert upstream flows via new storm drain in Chayote Road to Basin B; replace SAD 6 Pond # 6 outlet with ported riser pipe. This option would reduce the peak discharge from the pond to approximately 30cfs.In addition, the diversion of flows to Basin B would significantly decrease the total runoff volume conveyed by WC\_02Aand protect the arroyo reach from erosion.

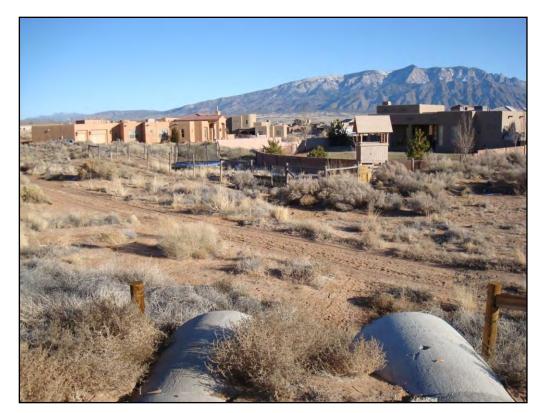
Photo 9: Home located in former flow path of Arroyo, looking east from SAD 6 Pond # 6; the outlet structure of the pond (two reinforced concrete pipes) can be seen at the bottom of the photo.

SAD 6 Pond # 6 (WC\_02P) was designed for a peak storage of approximately 3.4 AF. During DEVEX conditions, peak storage in the pond is 3.9 AF, with a peak outflow of 246 cfs. The pond attenuates flows only minimally; sediment-deprived outflow is released back into the historical flow path through two 54 inch RCP culverts. The pond discharges across a gas line easement and onto private property (Photo 9); no public drainage right-of-way exists between the outlet pipes and Nagoya Road. In addition, a home has been constructed in the former flow path, and discharge from the pond will cross the developed lot and cause erosion and flooding.

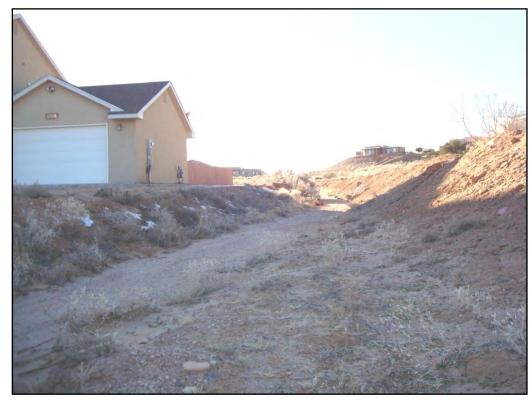
Photo 10: House in close proximity to the Arroyo, looking upstream from Demavend Road.

Further downstream, between Nagoya and Nativitas Road, residential lots are platted to the centerline of the arroyo; in several locations, homes have been built in close proximity to the arroyo (Photo 10) and may be subject to erosion and/or flooding during a large storm event (see Exhibit 6). The original plat for this area shows a generic 20 ft public drainage easement between Nagoya and Nativitas Road; ownership of the easement is unclear.

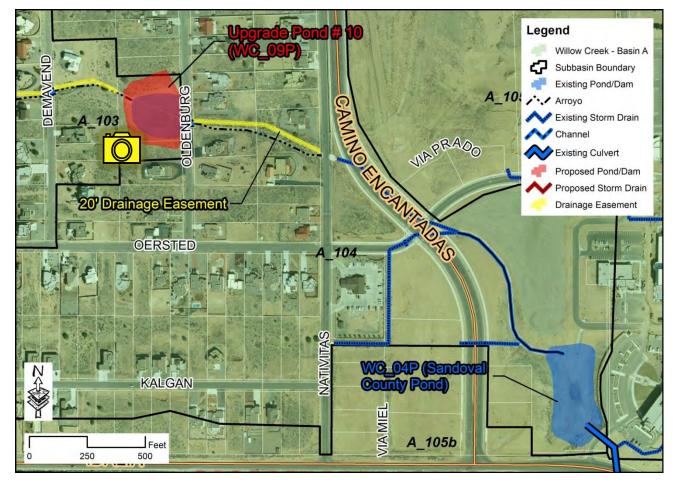
Exhibit 7: Map showing proposed improvements to SAD 5 Pond # 10 (WC\_09P)

Increase volume of existing pond to approximately 8 AF; two additional lots (total of 1 acre) will be required for this improvement. Modify outlet structure to decrease peak outflow and optimize attenuating effect of the pond. With improvements in place, ULTIMATE conditions peak flows could be reduced to approximately 136 cfs. This assumes a fully developed watershed with all upstream improvements in place (WC\_07P, WC\_08P and WC\_02M, see above).

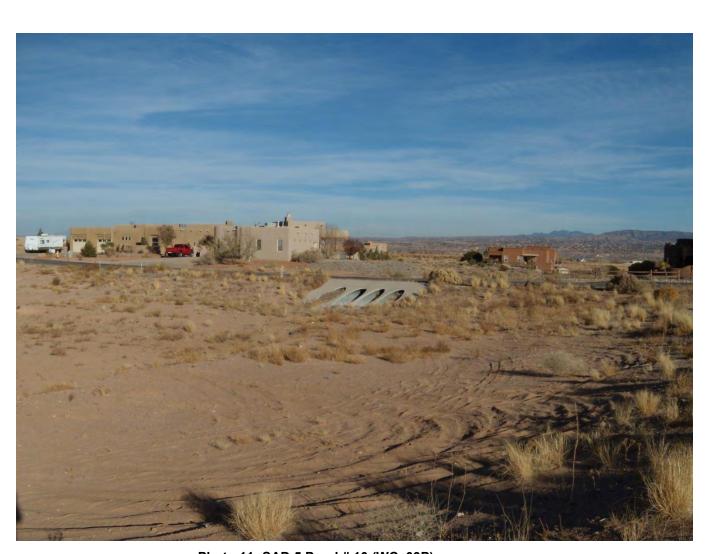
Photo 11: SAD 5 Pond # 10 (WC\_03P)

SAD 5 Pond # 10 (WC\_03P, Photo 11) doesn't have a deficiency, but provides an opportunity for drainage improvements that would alleviate problems further downstream in the watershed. Peak storage in the pond is 2.7 AF under EXISTING and 3.7 AF under DEVEX conditions. Both values are below the estimated capacity of 4 AF. Under EXISTING conditions, the pond reduces 100-year peak flows from 256 cfs to 231 cfs. Under DEVEX conditions, flows are reduced from 344 to 290 cfs. Increasing the storage volume in the pond and restricting outflow would help mitigate capacity constraints at NM528 (see Section IV.A.5below)

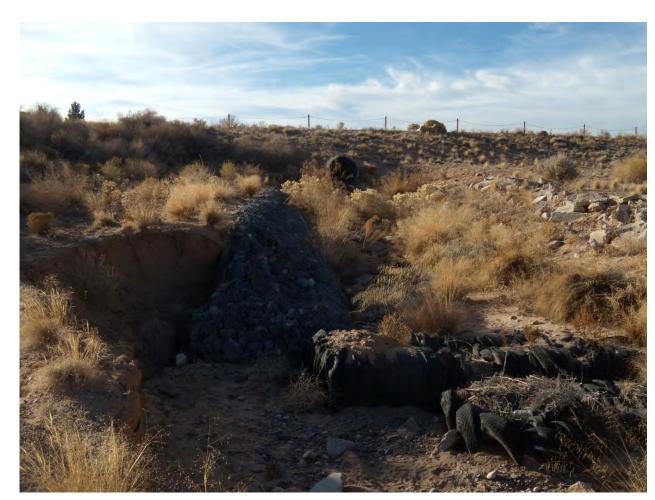
Photo 12: Failing tire bale drop structure downstream of Willow Creek Road.

Flows from Basin A cross NM 528 through a set of culverts (estimated capacity: 335 cfs) just south of Idalia Road (Photo 13). Those culverts are undersized for the 100-year storm under DEVEX conditions (peak flow: 402 cfs); further downstream, the Willow Creek crossing structure with a capacity of 290 cfs is undersized both for EXISTING conditions (382 cfs) and DEVEX conditions(489 cfs, see Photo 14). In the earthen channel downstream of Willow Creek Road, several tire bale drop structures are failing (Photo 12).

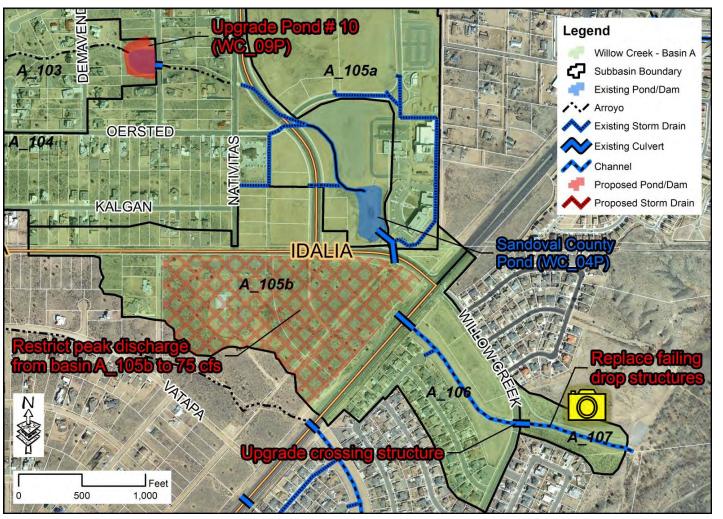
Exhibit 8: Map showing proposed drainage improvements in the lower portion of Basin A

Either increase capacity of crossing structure at Willow Creek Road or utilize existing CoRR drainage right-of-way upstream of crossing for a small stormwater detention pond.

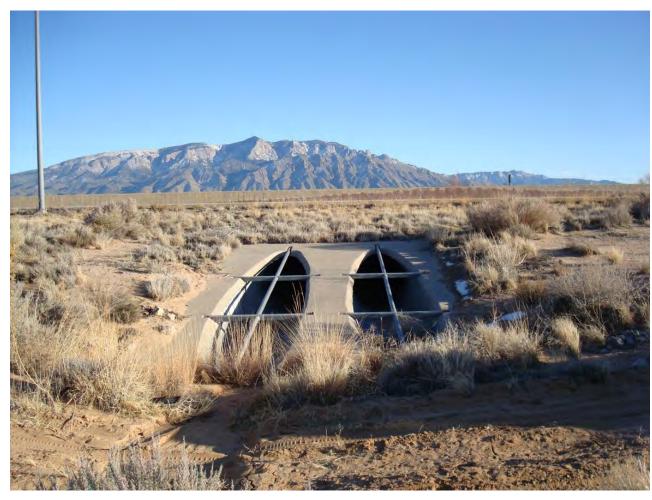
Photo 13: Culverts at NM 528 and Basin A (2 –60" CMP, capacity ≈ 335 cfs)

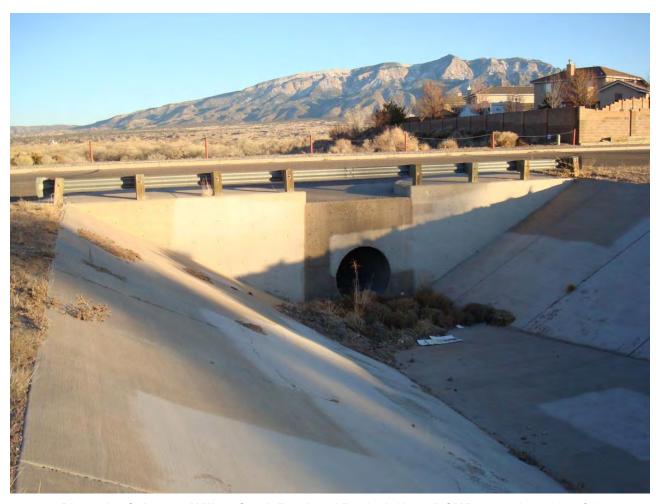
Photo 14: Culvert at Willow Creek Road and Basin A (1 –66" CMP, capacity ≈ 290 cfs)

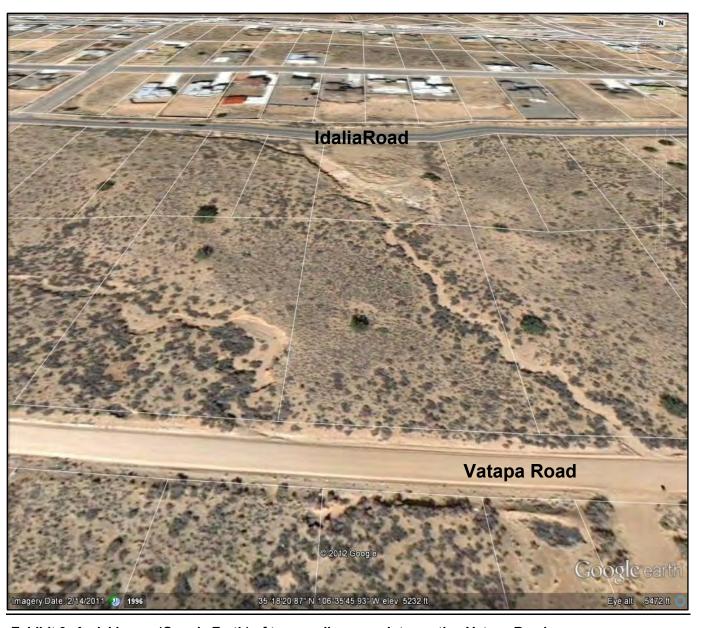
Exhibit 9: Aerial image (Google Earth) of two small arroyos intersecting Vatapa Road.

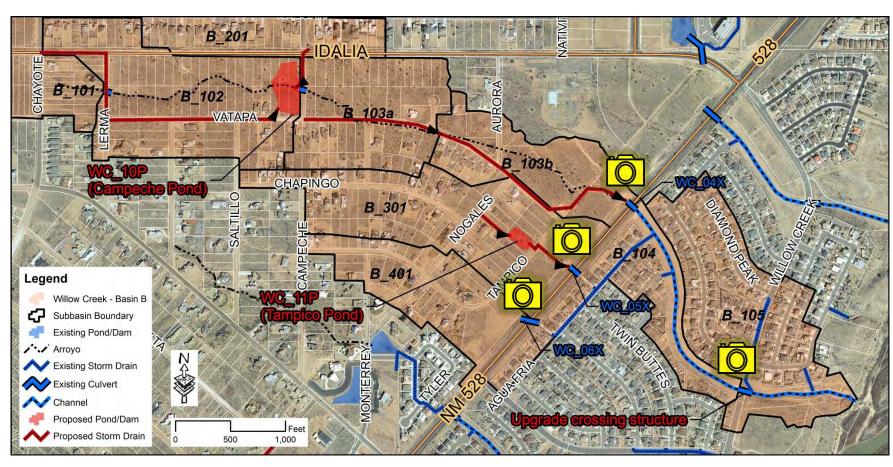
Exhibit 10: Map showing drainage improvement options in Basin B.

Increase capacity of crossing structure at Willow Creek Road or allow flows in excess of the culvert capacity to cross roadway (curb cuts) and re-enter the existing channel downstream of Willow Creek Road.

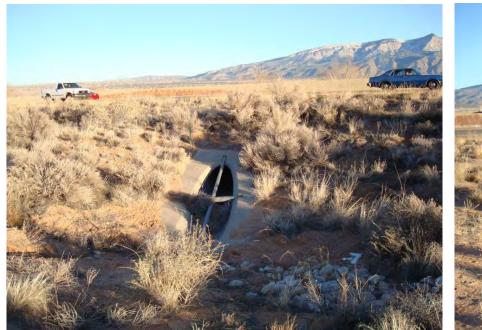
Photo 16: Crossing WC\_05X (left, 1 – 36" CMP, capacity ≈ 46 cfs) and WC\_06X (right, 1 – 36" CMP, capacity ≈ 71 cfs)

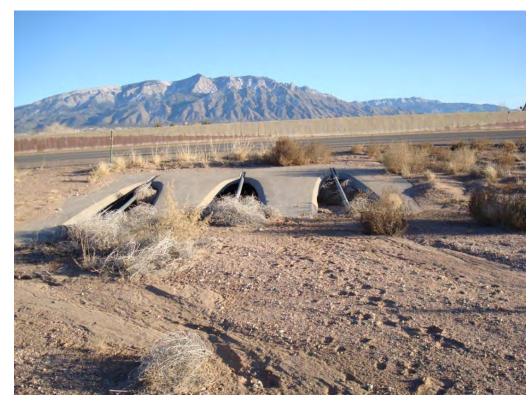
Photo 15: Crossing WC\_04X (3 – 60" CMP, capacity ≈ 422 cfs)

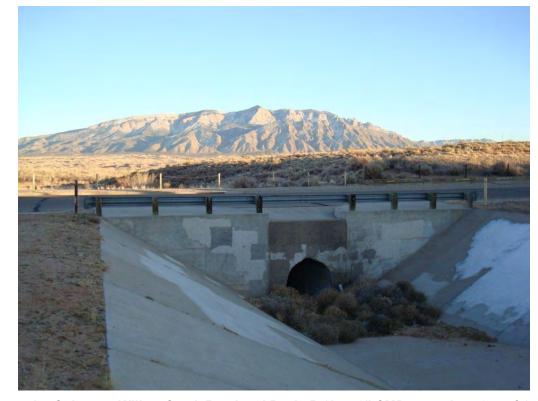
17: Culvert at Willow Creek Road and Basin B (1 – 72" CMP, capacity ≈ 355 cfs)

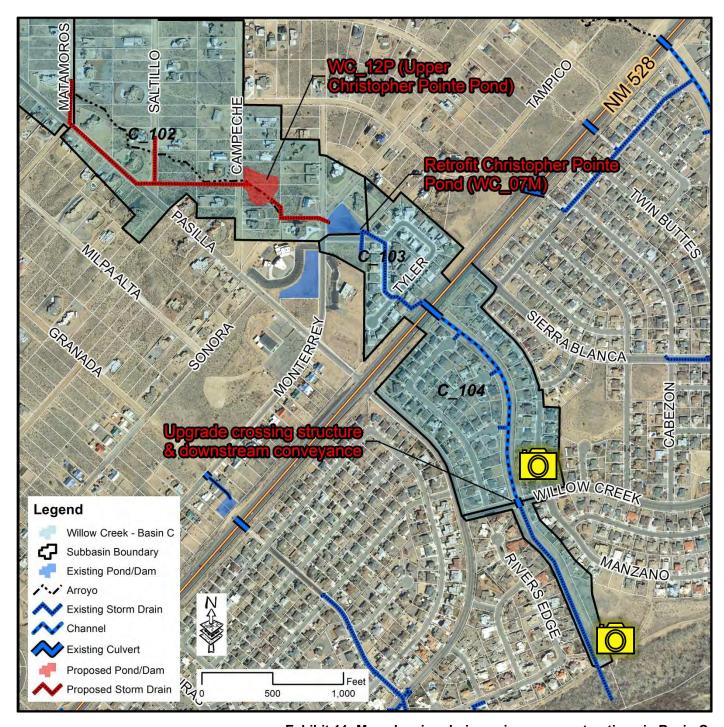
Exhibit 11: Map showing drainage improvement options in Basin C.

Even with all upstream improvements in place, there is insufficient detention volume to reduce peak flow rates at Willow Creek Road below the capacity of the existing culvert and storm drain. One potential solution would be to allow flows in excess of the culvert capacity to cross the roadway and utilize the public right-of-way downstream to convey the excess runoff the Rio Grande.

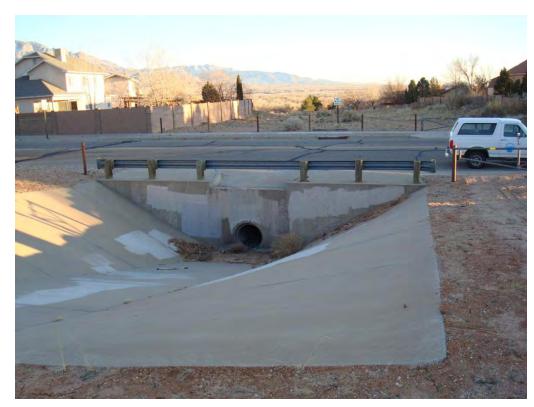
Photo 19: Storm drain inlet at Willow Creek Road in Basin C (36" RCP, capacity ≈ 90 cfs).

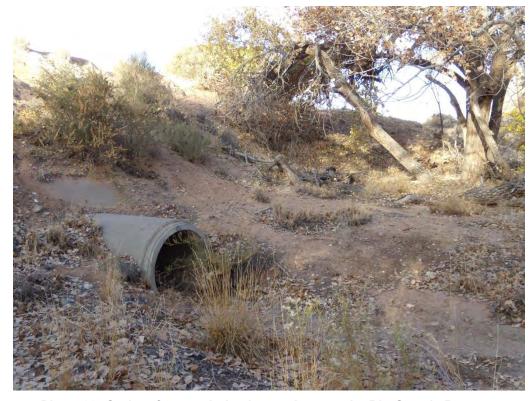
Photo 20: Outlet of storm drain shown above to the Rio Grande Bosque.

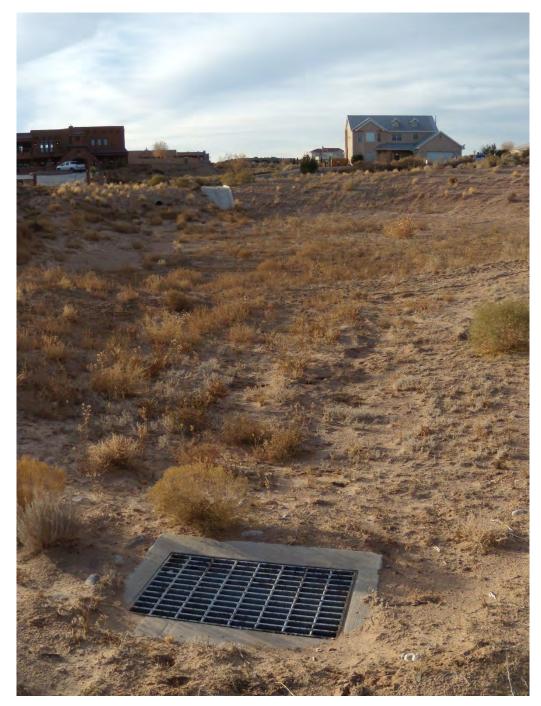
Photo 21: Christopher Pointe Pond (WC\_06P), with the outlet structure visible in the foreground.

Replace existing outlet with ported riser pipe to improve efficiency, minimize maintenance and improve water quality.
