**GEOTECHNICAL ENGINEERING  
SERVICES REPORT  
NO. 1-90712**

**LISBON AVENUE BOX CULVERT  
@ SUGAR CHANNEL**

**RIO RANCHO, NEW MEXICO**

**RE: Geotechnical Engineering Services Report  
Lisbon Ave. Box Culvert @ Sugar Channel  
Rio Rancho, New Mexico**

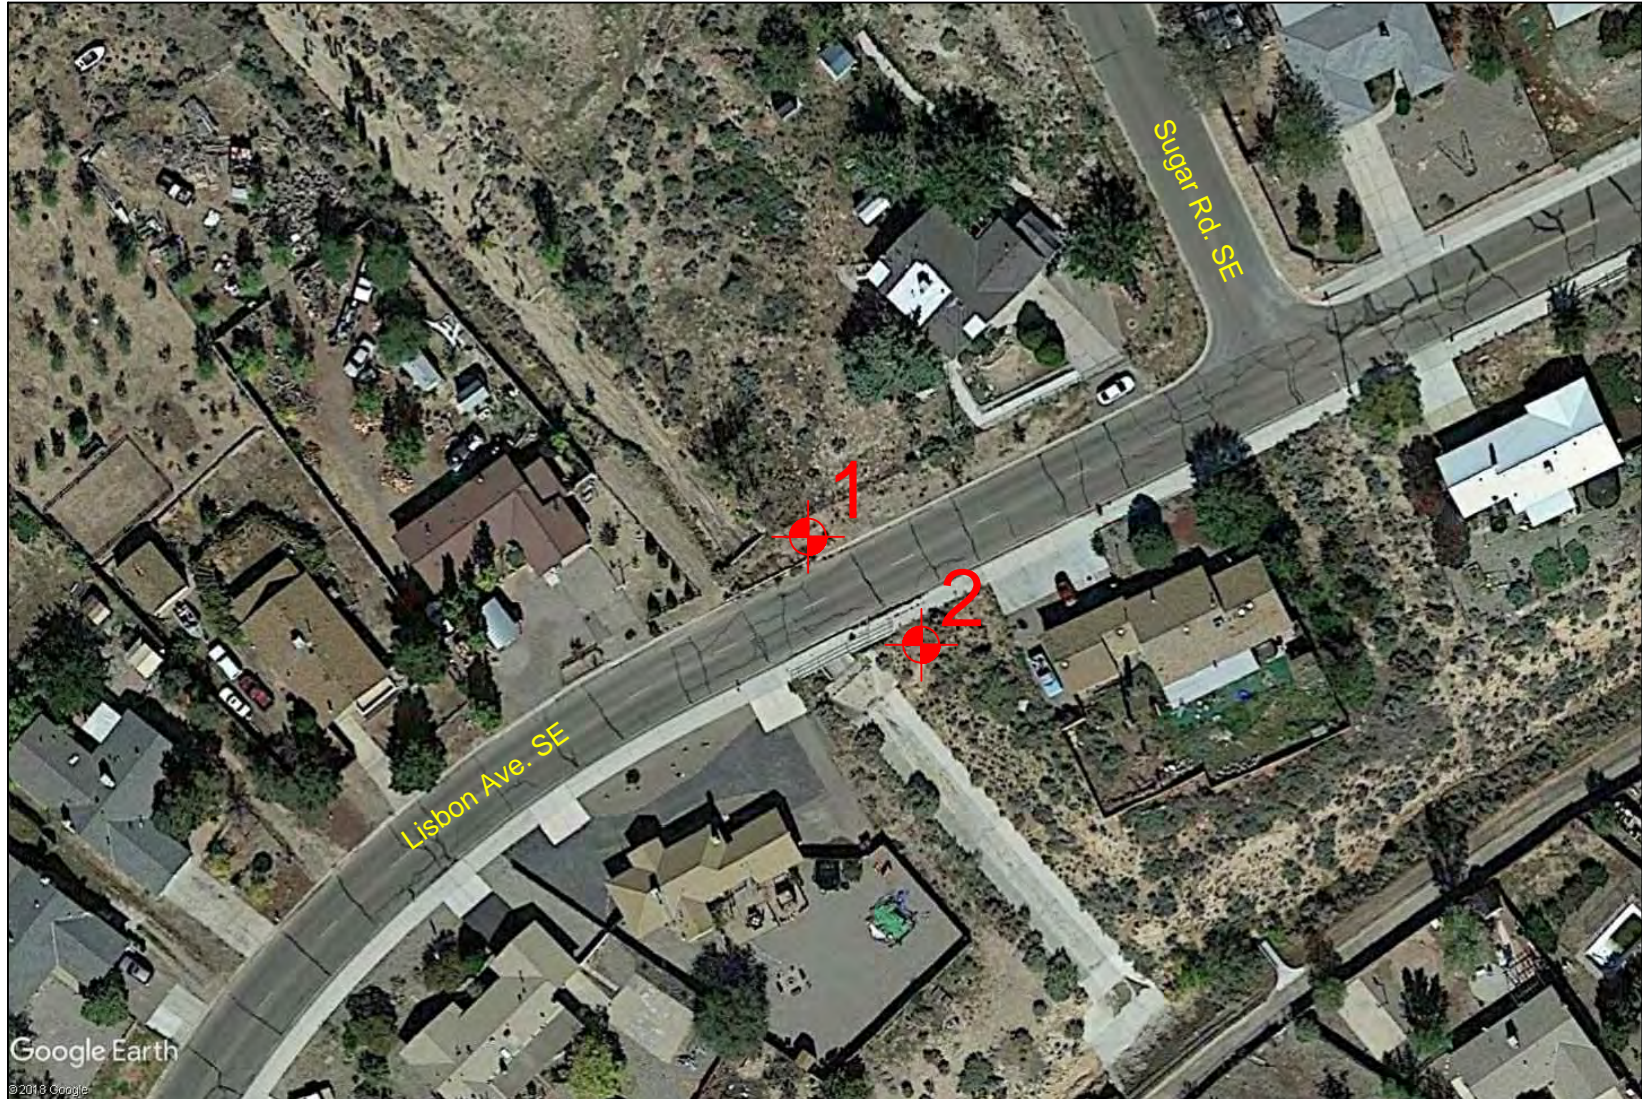
Figure 1

# BORING LOCATION MAP

Lisbon Ave. Box Culvert  
Rio Rancho, New Mexico  
Job No. 1-90712

Two (2) exploratory borings were drilled at the site to a depth of 15 feet below existing grade. Locations of the borings are shown on the attached Boring Location Map, Figure 1. The soils encountered in the borings were continuously examined, visually classified and logged during the drilling operation. The boring logs are presented in a following section of this report. Drilling was accomplished using a truck mounted drill rig equipped with 5.5-inch diameter continuous flight hollow stem auger. Subsurface soils were sampled at five foot intervals or less utilizing an open tube split barrel sampler driven by a standard penetration test hammer.
