# Existing Conditions Hydraulic Analysis Report: Montoyas Arroyo, Harvey Jones Channel

**EXISTING CONDITIONS HYDRAULIC ANALYSIS REPORT FOR THE MONTOYAS ARROYO  
FROM THE HARVEY JONES CHANNEL INLET TO THE RIO GRANDE**

**SOUTHERN SANDOVAL COUNTY ARROYO FLOOD CONTROL AUTHORITY**

**BOHANNAN HUSTON, INC.**

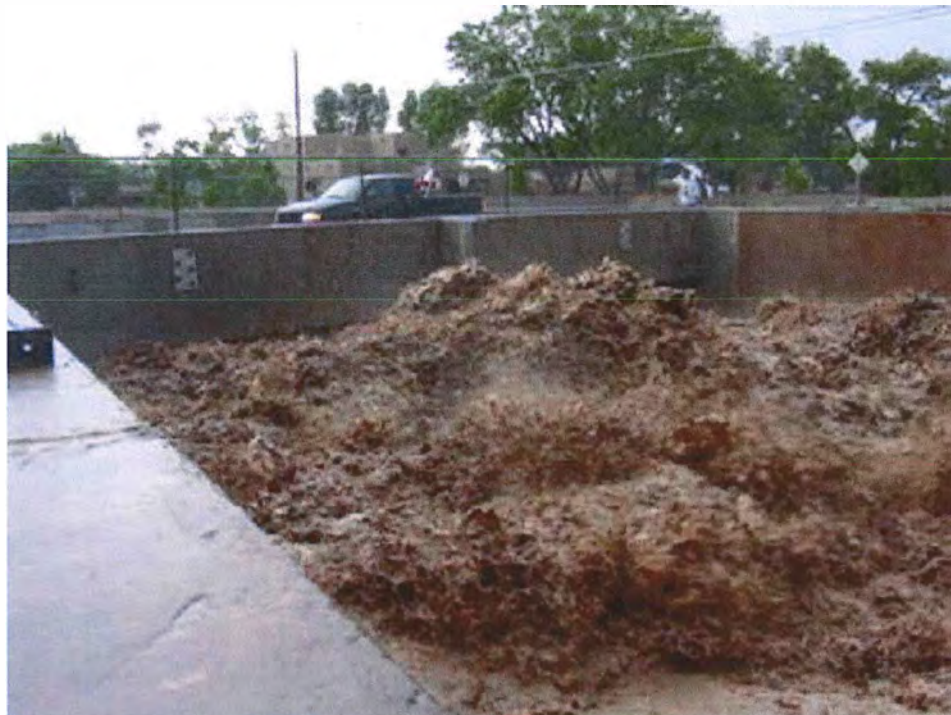
This memo is a supplement to the DRAFT Design Analysis Report (DAR) prepared for the Harvey Jones Channel Improvements Project dated November 21, 2012. It summarizes the hydraulic analysis performed at the Harvey Jones Channel from upstream of the existing Corrales Road Bridge to the end of the SSCAFCA property where the Middle Rio Grande Conservancy District's (MRGCD) inverted siphon is located (see Figures 4 & 7). This memo also discusses the assumptions that are included in the hydraulic analysis along with a discussion of the results. The hydraulic analysis contained herein is assuming that there is no sediment deposition in Harvey Jones Channel (HJC). We recognize however, and as we have seen from previous storm events, that any sediment deposition under or downstream of the existing bridge degrades the hydraulic capacity of the structure, resulting in the formation of a hydraulic jump occurring upstream of the bridge, as shown in the following picture.

As discussed in Section IV.B.1 Existing Conditions of the DAR, the existing channel upstream of the bridge is 40 feet wide and 10 feet deep, with an upstream slope of about 1.6%. At the bridge, the channel transitions to a 0.0% slope section and the width widens to 46 feet. The bridge is comprised of two CBC's that are 22.5' x 8.3' (w x h). From survey data of the bridge, the low chord is at an elevation of 5032.4. Downstream of the bridge, the channel then gradually transitions to 80 feet wide and remains flat for about 700 feet, ending with a concrete sill that is 3 feet in height.

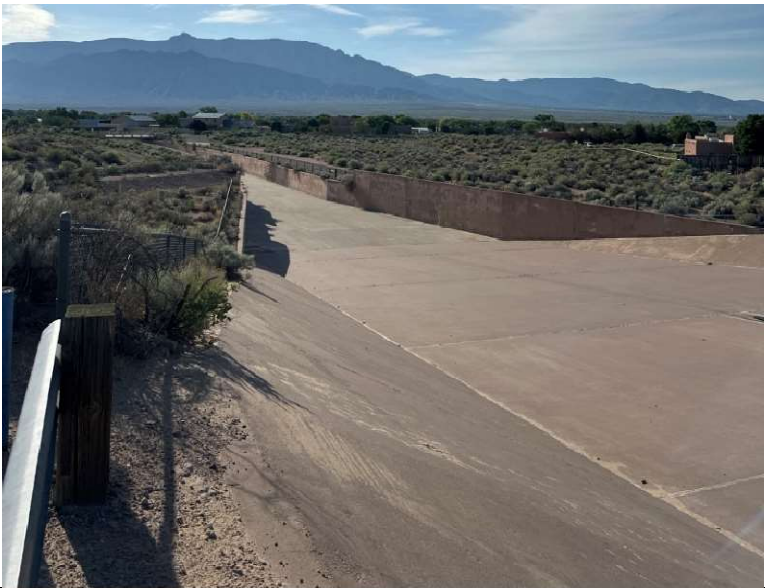
| Observation Location | Description | Photo(s) |
|---|---|---|
| <p>Location 1</p> <p>Lat: 35° 15' 25.11" N<br/>Long: 106° 36' 55.47" W</p> | <p>Name: Photo 1</p> <p>Feature Category: HJC Structure</p> <p>Description: HJC Inlet and downstream channel as seen from the northern top of inlet, looking east.</p> | |

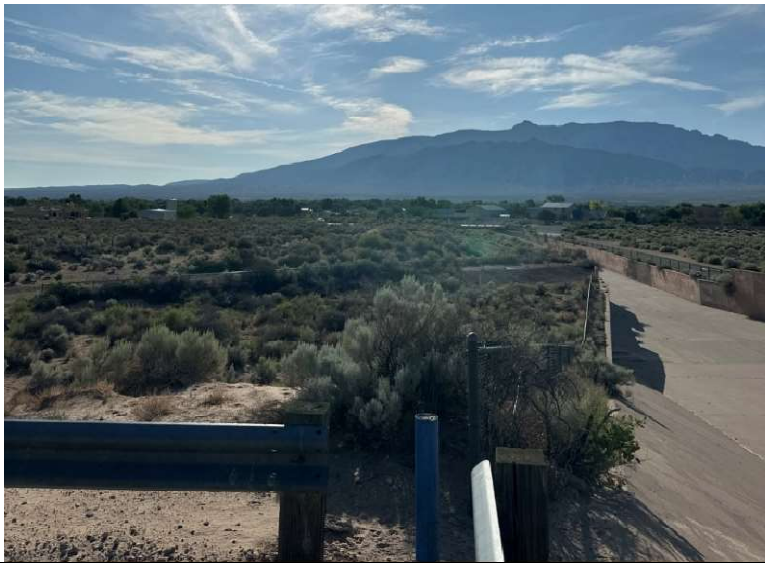
| Observation Location | Description | Photo(s) |
|---|---|---|
| <p>Location 1</p> <p>Lat: 35° 15' 25.11" N<br/>Long: 106° 36' 55.47" W</p> | <p>Name: Photo 2</p> <p>Feature Category: HJC Structure</p> <p>Description: HJC Inlet and fencing as seen from the northern top of inlet, looking east.</p> | |

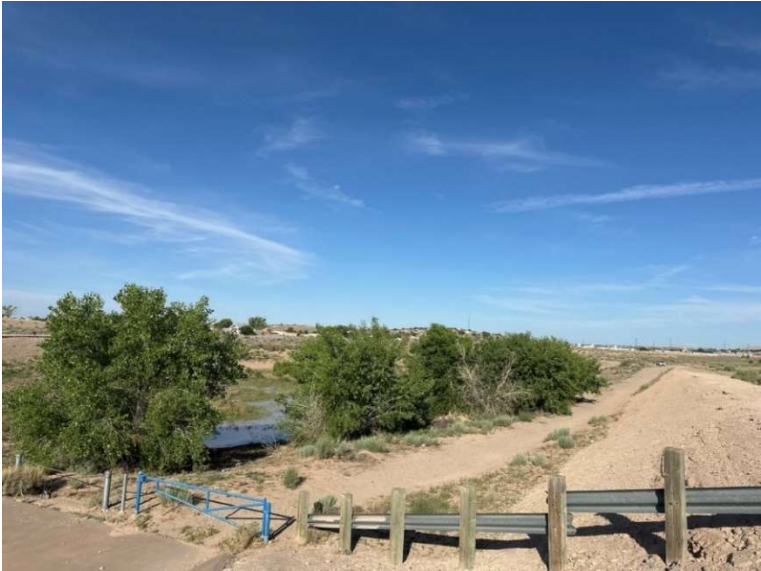
| <p>Location 1</p> <p>Lat: 35° 15' 25.11" N<br/>Long: 106° 36' 55.47" W</p> | <p>Name: Photo 3</p> <p>Feature Category: HJC Structure</p> <p>Description: HJC Inlet upstream basin as seen from the northern berm at the top of the concrete inlet, looking west.</p> | <p>A photograph showing a dirt road in the foreground with a blue metal fence. In the background, there is a small body of water (the inlet) surrounded by green trees and shrubs under a clear blue sky.</p> |

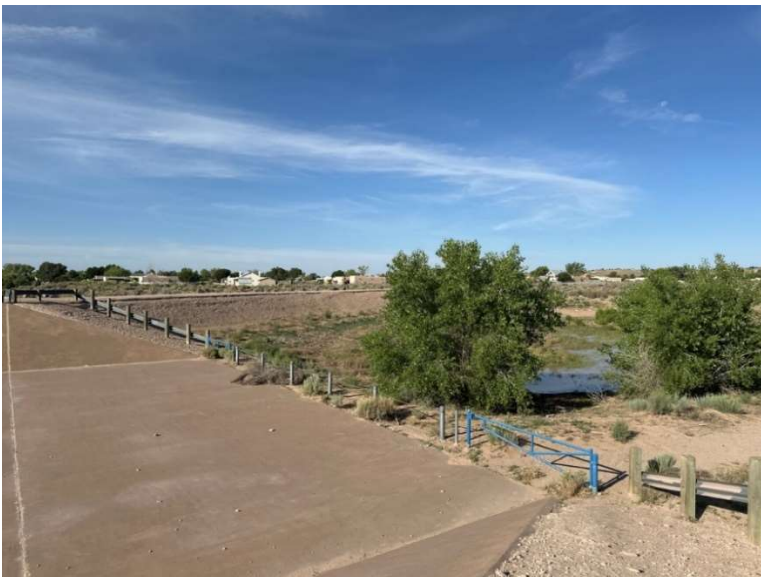
| <p>Location 1</p> <p>Lat: 35° 15' 25.11" N<br/>Long: 106° 36' 55.47" W</p> | <p>Name: Photo 4</p> <p>Feature Category: HJC Structure</p> <p>Description: HJC Inlet upstream basin as seen from the northern access road to the inlet, looking west.</p> | <p>A photograph showing a wide, flat, brownish area (likely a dry basin or access road) in the foreground. A blue metal fence runs along the edge. In the background, there is a small body of water (the inlet) surrounded by green trees and shrubs under a clear blue sky.</p> |

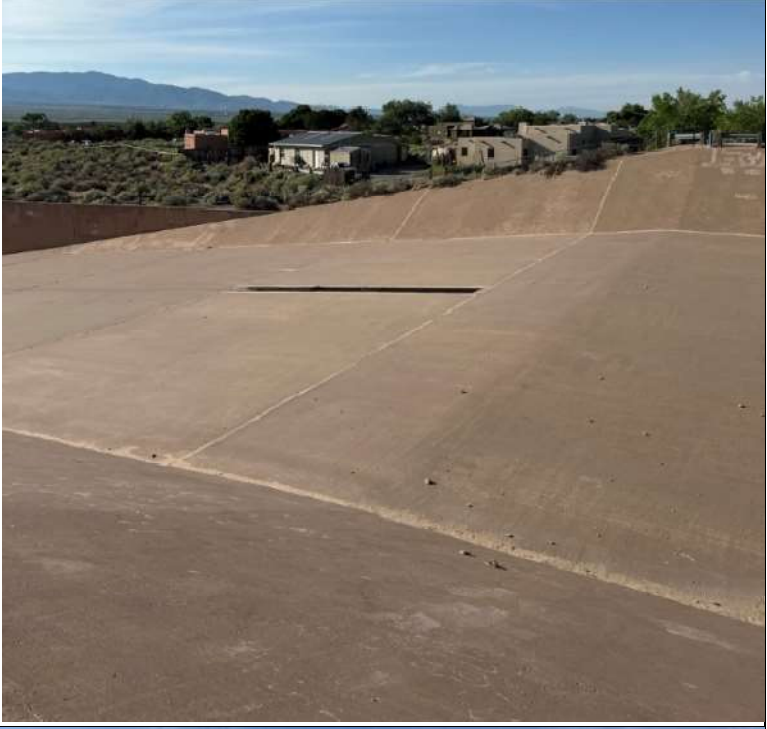
| <p>Location 1</p> <p>Lat: 35° 15' 25.11" N<br/>Long: 106° 36' 55.47" W</p> | <p>Name: Photo 5</p> <p>Feature Category: HJC Structure</p> <p>Description: HJC Inlet crest and drain from upstream basin as seen from the northern top of slope, looking southeast.</p> | |

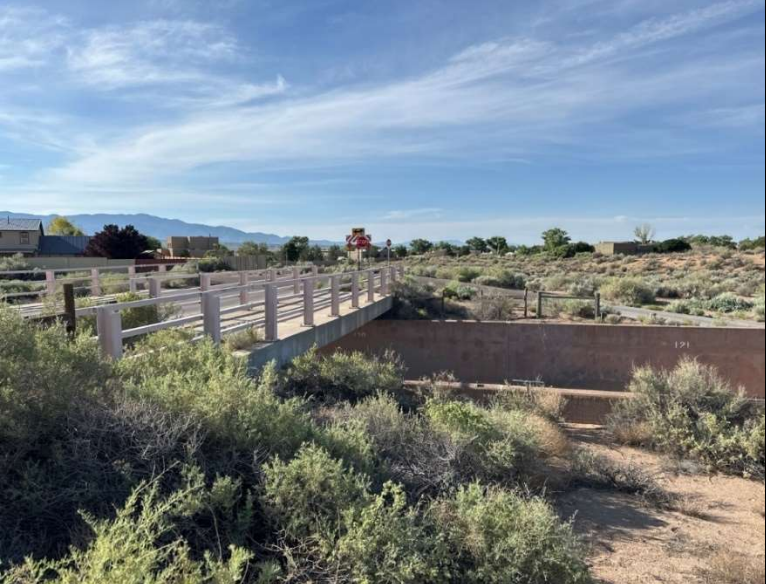
| <p>Location 2</p> <p>Lat: 35° 15' 24.87" N<br/>Long: 106° 36' 47.59" W</p> | <p>Name: Photo 6</p> <p>Feature Category: HJC Structure</p> <p>Description: Loma Larga bridge upstream face as seen from the top of the northern embankment, looking south.</p> | |

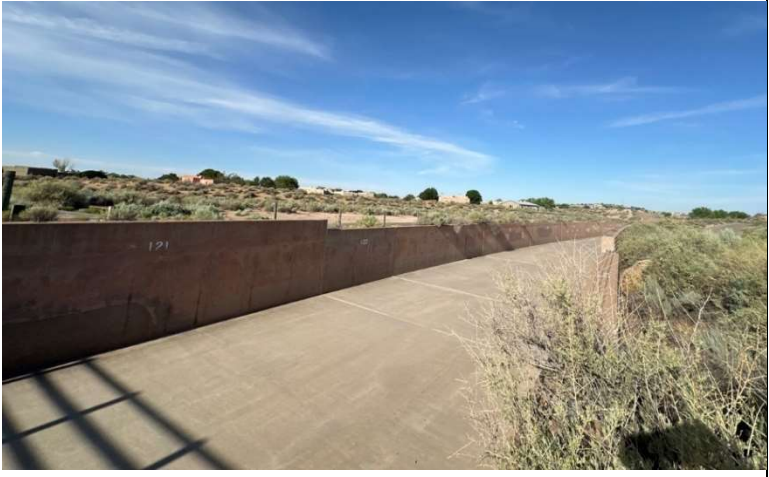
| <p>Location 2</p> <p>Lat: 35° 15' 24.87" N<br/>Long: 106° 36' 47.59" W</p> | <p>Name: Photo 7</p> <p>Feature<br/>Category: HJC<br/>Structure</p> <p>Description:<br/>Channel<br/>upstream of<br/>Loma Larga<br/>bridge as seen<br/>standing near<br/>the north<br/>channel wall<br/>upstream of<br/>the structure,<br/>looking west.</p> | |

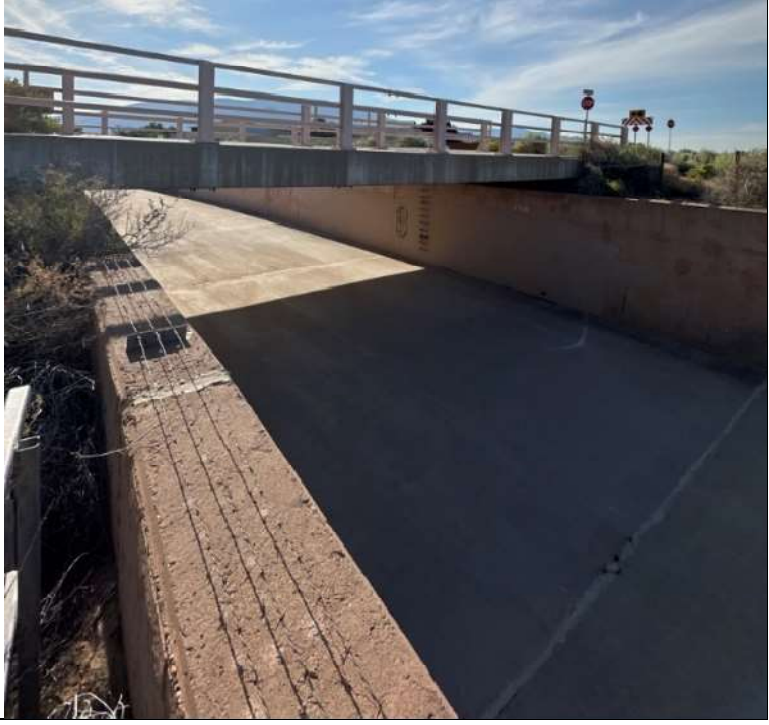
| <p>Location 2</p> <p>Lat: 35° 15' 24.87" N<br/>Long: 106° 36' 47.59" W</p> | <p>Name: Photo 8</p> <p>Feature<br/>Category: HJC<br/>Structure</p> <p>Description:<br/>Inside Loma<br/>Larga bridge<br/>upstream face<br/>as seen from<br/>the top of the<br/>northern<br/>channel wall,<br/>looking south.</p> | |

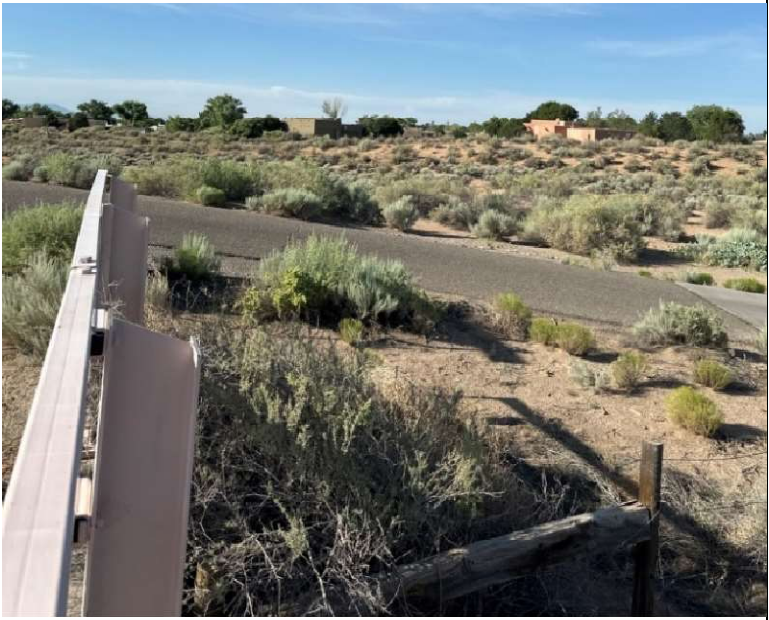
| <p>Location 3</p> <p>Lat: 35° 15' 24.25" N</p> <p>Long: 106° 36' 47.24" W</p> | <p>Name: Photo 9</p> <p>Feature Category: HJC Structure</p> <p>Description: The southern embankment adjacent to Harvey Jones Channel as seen from the southern upstream edge of the Loma Larga bridge, looking south.</p> | |

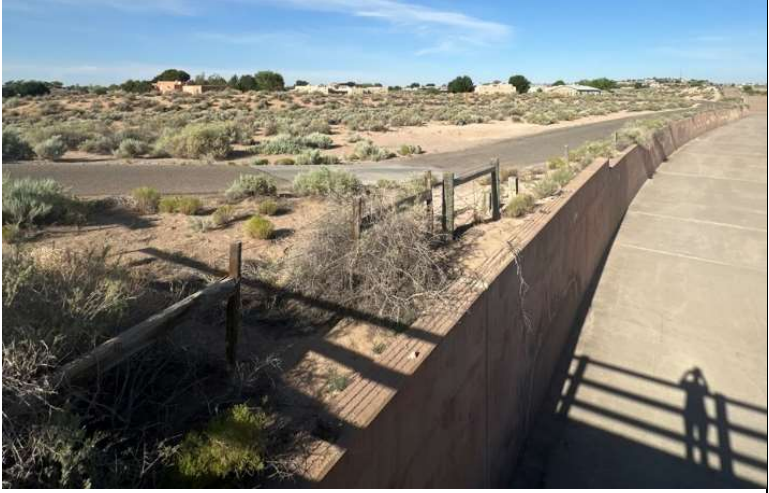
| <p>Location 3</p> <p>Lat: 35° 15' 24.25" N</p> <p>Long: 106° 36' 47.24" W</p> | <p>Name: Photo 10</p> <p>Feature Category: HJC Structure</p> <p>Description: Harvey Jones Channel upstream of Loma Larga bridge as seen on Loma Larga bridge looking west,</p> | |

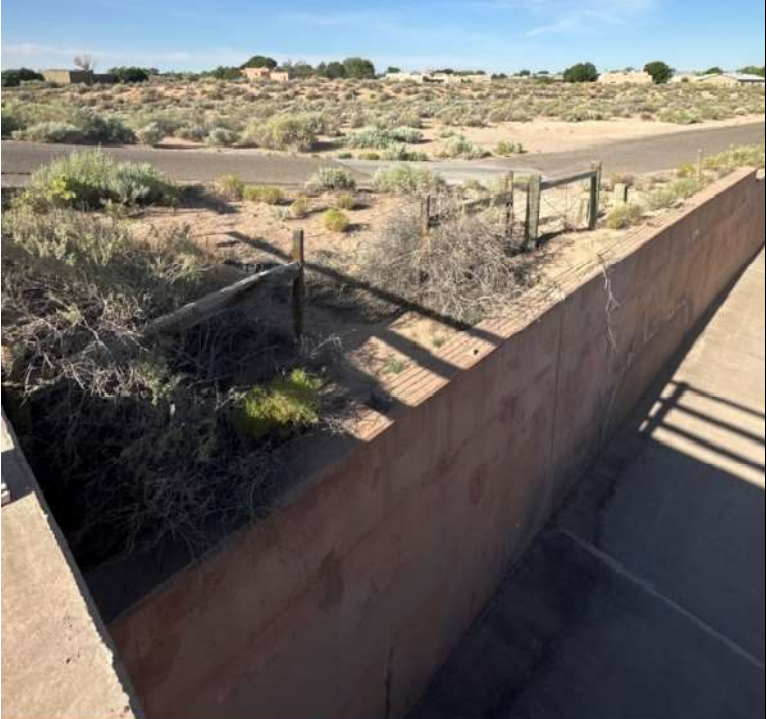
| <p>Location 3</p> <p>Lat: 35° 15' 24.25" N</p> <p>Long: 106° 36' 47.24" W</p> | <p>Name: Photo 11</p> <p>Feature Category: HJC Structure</p> <p>Description: Southern Harvey Jones Channel wall upstream of Loma Larga bridge as seen on Loma Larga bridge looking southwest.</p> | |

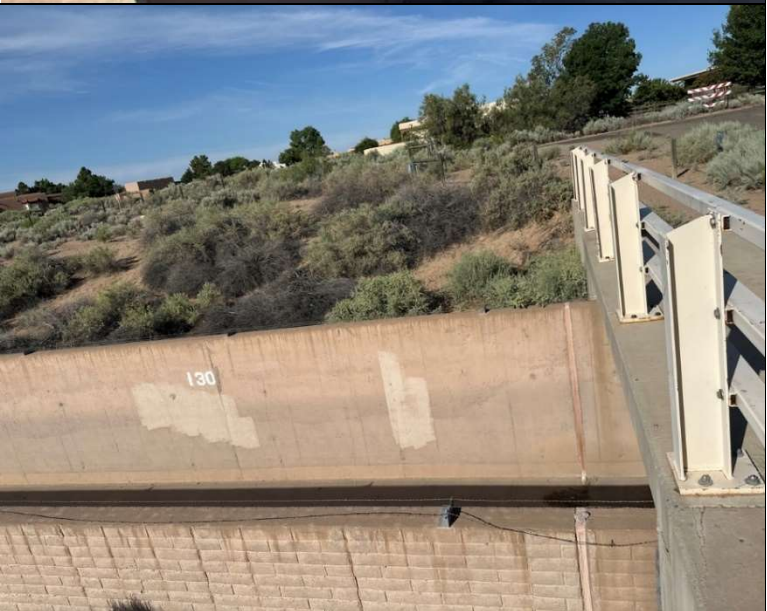
| <p>Location 4</p> <p>Lat: 35° 15' 39.54" N</p> <p>Long: 106° 36' 48.2" W</p> | <p>Name: Photo 12</p> <p>Feature Category: HJC Structure</p> <p>Description: Dulcelina Curtis Channel walls at the Vasa Wy crossing as seen from the Vasa Wy crossing, looking southwest.</p> | |

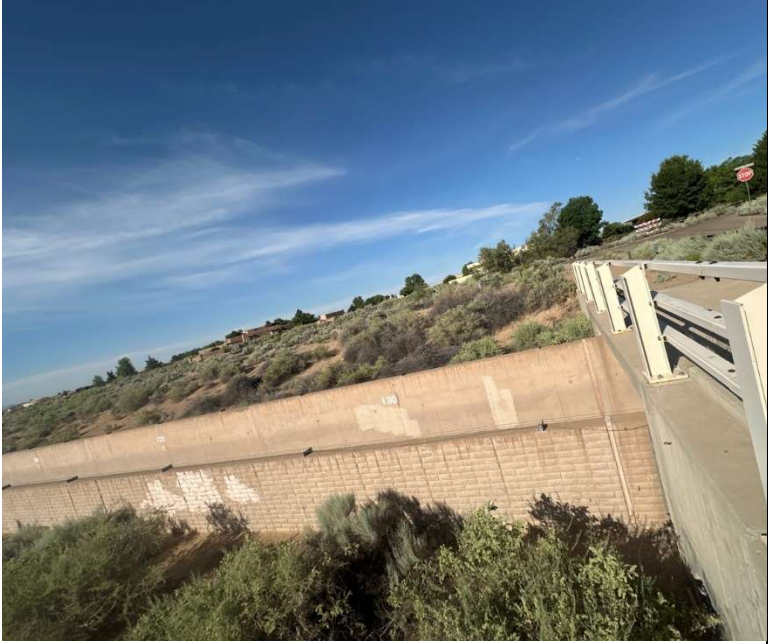
| <p>Location 4</p> <p>Lat: 35° 15' 39.54" N</p> <p>Long: 106° 36' 48.2" W</p> | <p>Name: Photo 13</p> <p>Feature Category: HJC Structure</p> <p>Description: Dulcelina Curtis Channel walls and adjacent eastern ground at the Vasa Wy crossing as seen from the Vasa Wy crossing, looking southwest.</p> | |

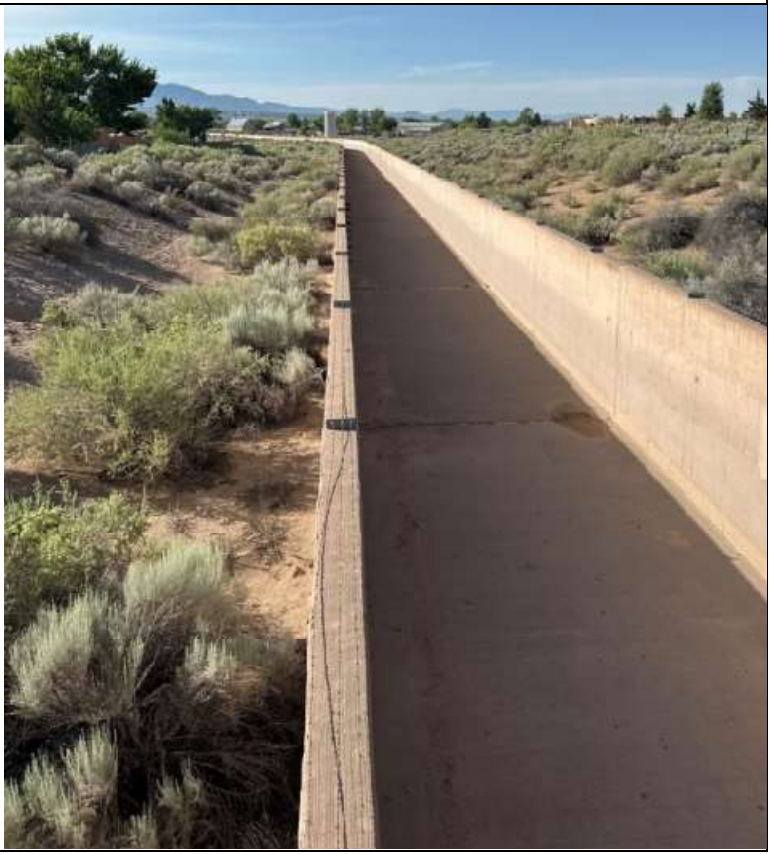
| <p>Location 4</p> <p>Lat: 35° 15' 39.54" N</p> <p>Long: 106° 36' 48.2" W</p> | <p>Name: Photo 14</p> <p>Feature Category: HJC Structure</p> <p>Description: Dulcelina Curtis Channel at the Vasa Wy crossing as seen from the Vasa Wy crossing, looking southeast.</p> | |

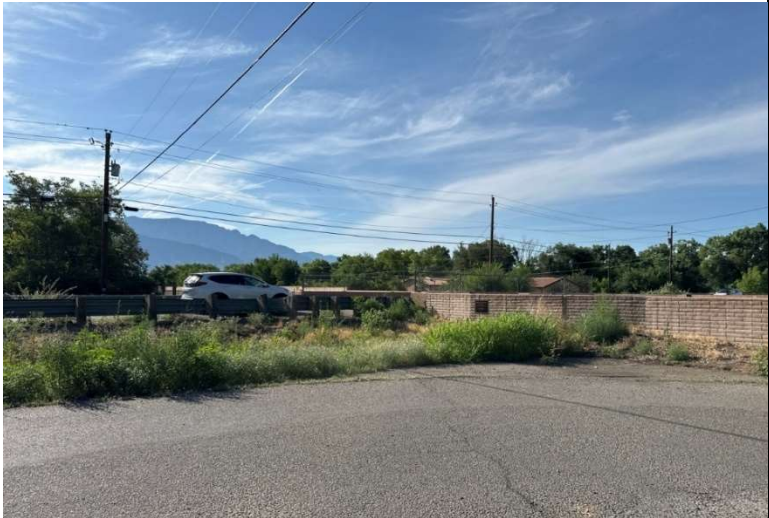
| <p>Location 5</p> <p>Lat: 35° 15' 40.03" N</p> <p>Long: 106° 36' 6.08" W</p> | <p>Name: Photo 15</p> <p>Feature Category: HJC Structure</p> <p>Description: Harvey Jones Channel northern wall, road crossing at Corrales crossing, and adjacent ground as seen from the corner of Calle Contenta adjacent to the crossing, looking southeast.</p> | |

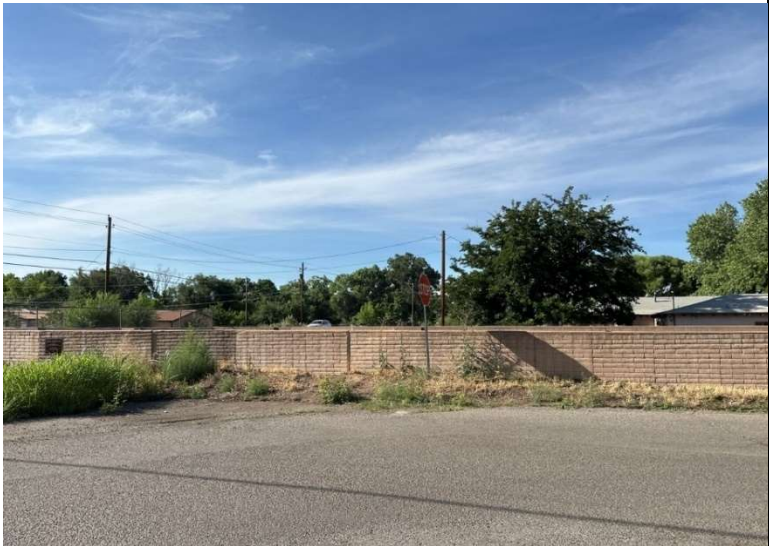
| <p>Location 5</p> <p>Lat: 35° 15' 40.03" N</p> <p>Long: 106° 36' 6.08" W</p> | <p>Name: Photo 16</p> <p>Feature Category: HJC Structure</p> <p>Description: Harvey Jones Channel northern wall at Corrales crossing and adjacent ground as seen from the corner of Calle Contenta adjacent to the crossing, looking southeast.</p> | |

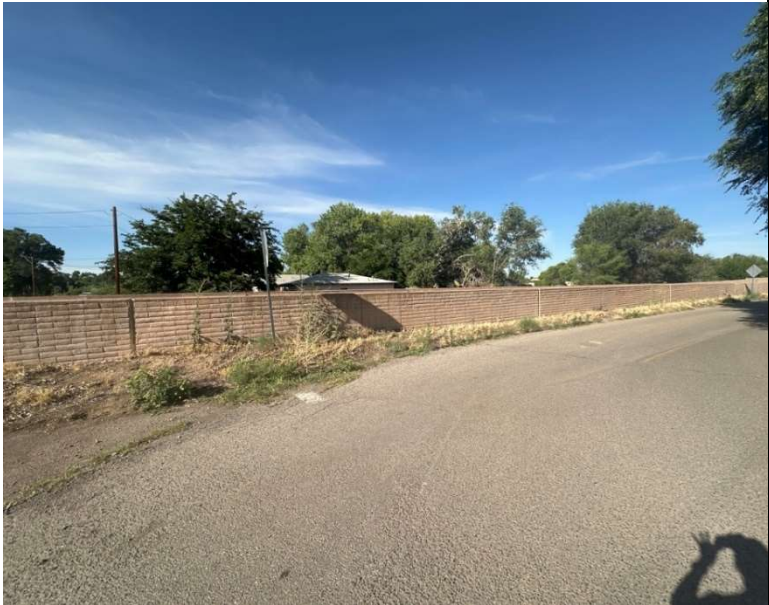
| <p>Location 5</p> <p>Lat: 35° 15' 40.03" N</p> <p>Long: 106° 36' 6.08" W</p> | <p>Name: Photo 18</p> <p>Feature Category: HJC Structure</p> <p>Description: Harvey Jones Channel northern wall at Corrales crossing and adjacent ground as seen from the corner of Calle Contenta adjacent to the crossing, looking southwest.</p> | |

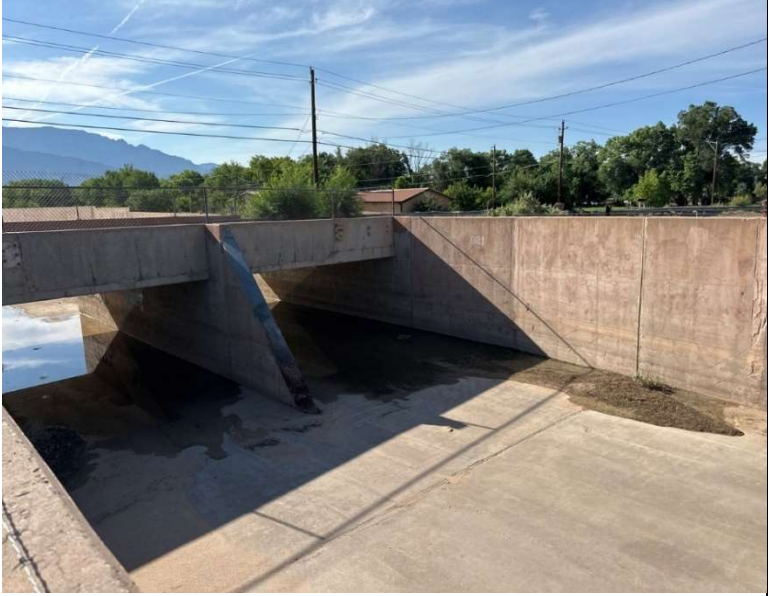
| <p>Location 5</p> <p>Lat: 35° 15' 40.03" N</p> <p>Long: 106° 36' 6.08" W</p> | <p>Name: Photo 20</p> <p>Feature Category: HJC Structure</p> <p>Description: Corrales Rd crossing of Harvey Jones Channel upstream face as seen from northern channel wall, looking southeast.</p> | |

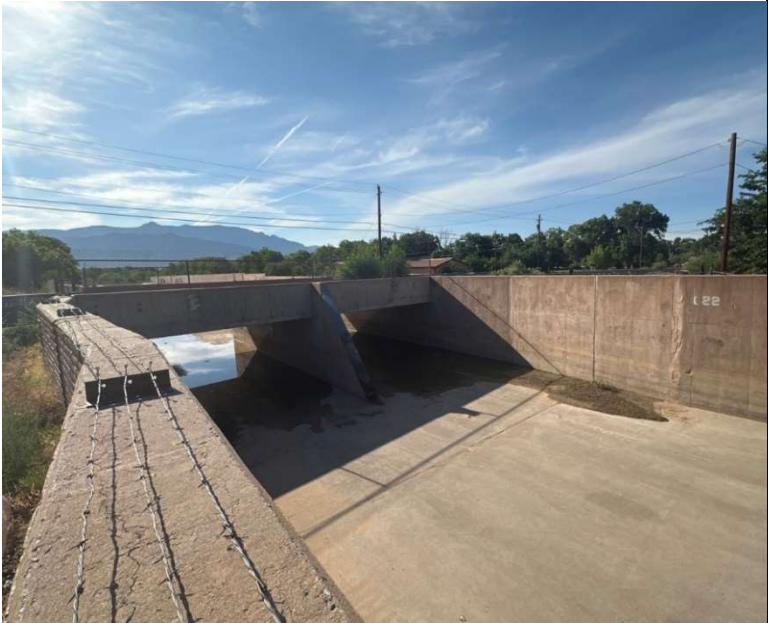
| <p>Location 5</p> <p>Lat: 35° 15' 40.03" N</p> <p>Long: 106° 36' 6.08" W</p> | <p>Name: Photo 21</p> <p>Feature Category: HJC Structure</p> <p>Description: Corrales Rd crossing of Harvey Jones Channel upstream face and upstream channel as seen from northern channel wall, looking southeast.</p> | |

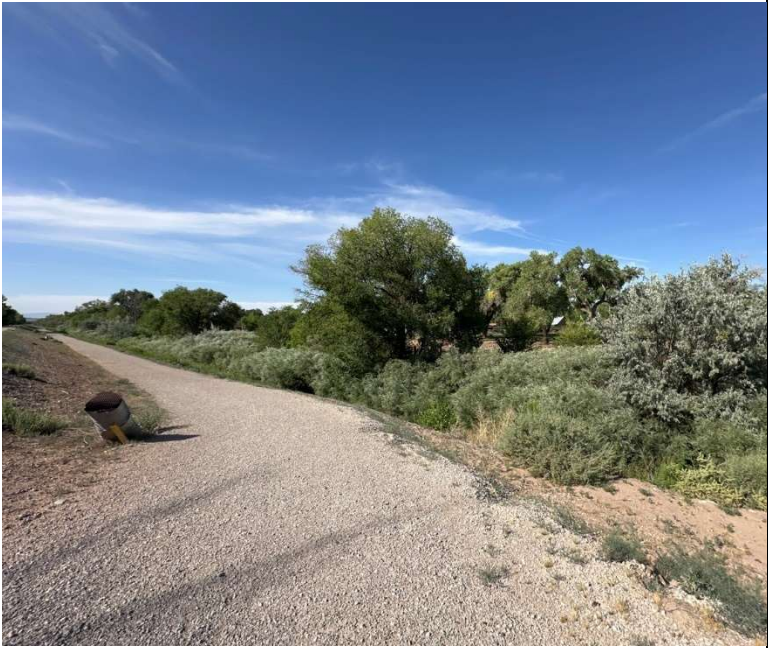
| <p>Location 6</p> <p>Lat: 35° 15' 34.66" N</p> <p>Long: 106° 35' 49.55" W</p> | <p>Name: Photo 22</p> <p>Feature Category: Rio Grande Levee</p> <p>Description: Property adjacent to the Rio Grande levee directly south of the Harvey Jones Channel outlet, as seen from the lower road (nearest to the Upper Corrales Riverside Drain), looking southwest.</p> | |

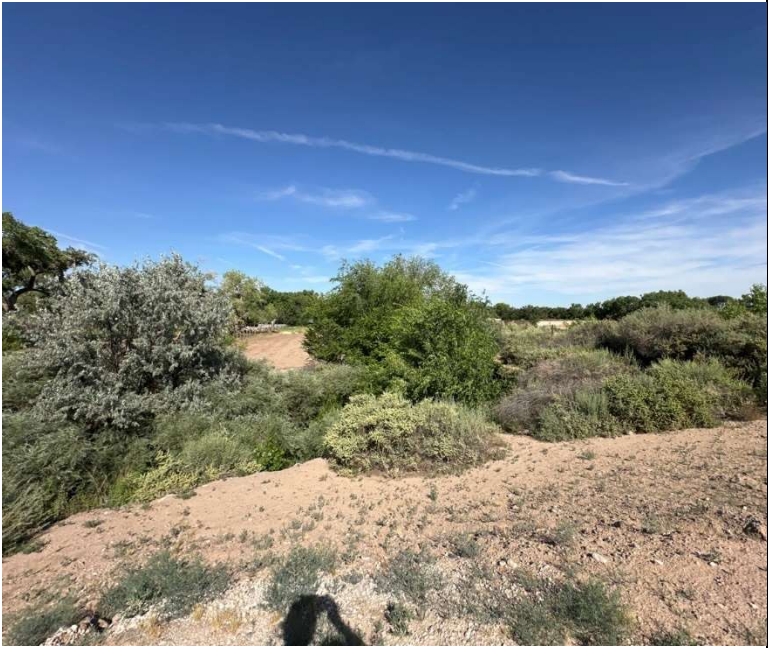
| <p>Location 6</p> <p>Lat: 35° 15' 34.66" N</p> <p>Long: 106° 35' 49.55" W</p> | <p>Name: Photo 23</p> <p>Feature Category: Rio Grande Levee</p> <p>Description: Property adjacent to the Rio Grande levee directly south of the Harvey Jones Channel outlet, as seen from the lower road (nearest to the Upper Corrales Riverside Drain), looking west.</p> | |

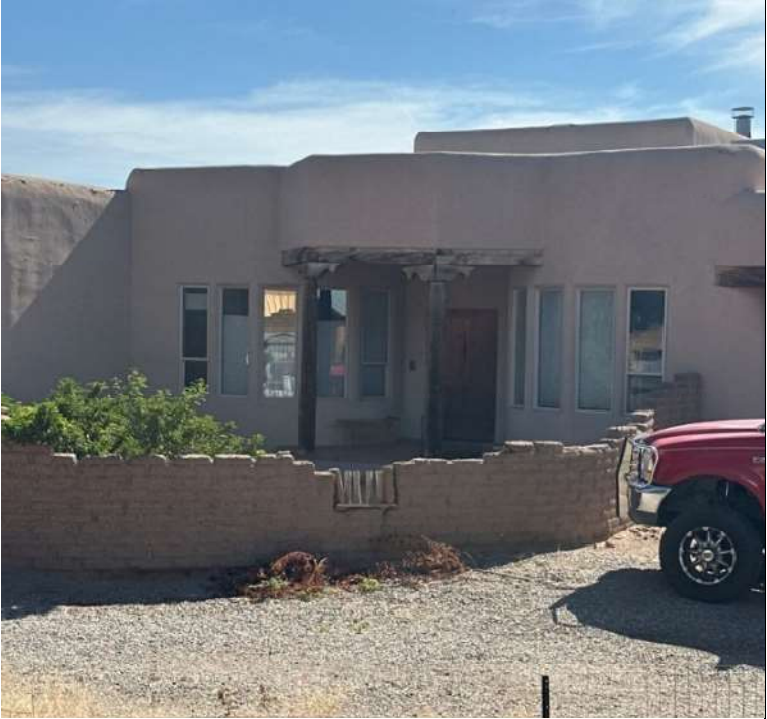
| <p>Location 11</p> <p>Lat: 35° 15' 10.82" N</p> <p>Long: 106° 35' 50.67" W</p> | <p>Name: Photo 30</p> <p>Feature Category: Building FFE Adjustment</p> <p>Description: One (1) step FFE adjustment necessary as seen from Lipe Rd, looking north.</p> <p>Address: 6770 Corrales Rd Corrales, NM 87048</p> | |

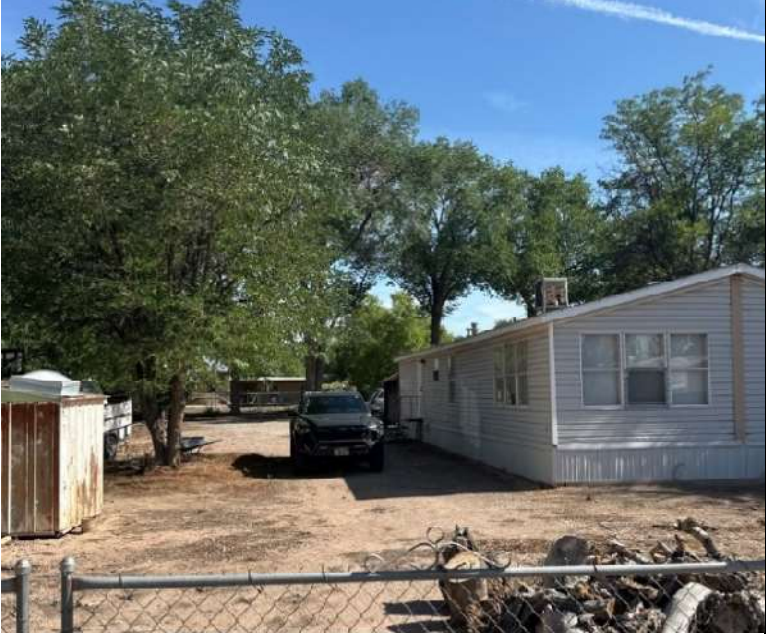
| <p>Location 12</p> <p>Lat: 35° 15' 16.52" N</p> <p>Long: 106° 36' 5.21" W</p> | <p>Name: Photo 31</p> <p>Feature Category: Building FFE Adjustment</p> <p>Description: Four (4) steps FFE adjustment necessary as seen from Kings Ln, looking north.</p> <p>Address: 90 Cottonwood Ln Corrales, NM 87048</p> | |

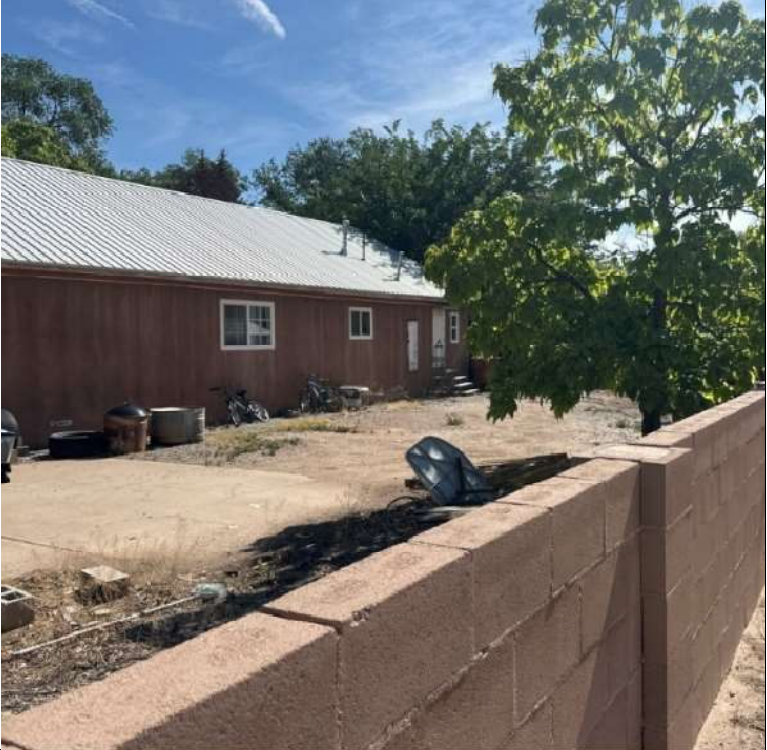
| <p>Location 13</p> <p>Lat: 35° 15' 16.6" N</p> <p>Long: 106° 36' 4.75" W</p> | <p>Name: Photo 32</p> <p>Feature Category: Building FFE Adjustment</p> <p>Description: Four (4) steps FFE adjustment necessary as seen from Kings Ln, looking north.</p> <p>Address: 84 Cottonwood Ln<br/>Corrales, NM 87048</p> | |

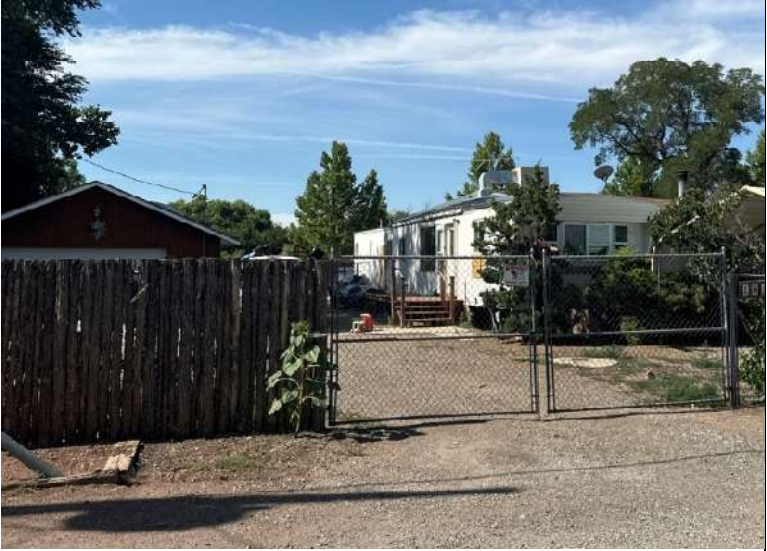
| <p>Location 14</p> <p>Lat: 35° 15' 16.37" N</p> <p>Long: 106° 36' 3.73" W</p> | <p>Name: Photo 33</p> <p>Feature Category: Building FFE Adjustment</p> <p>Description: Four (4) steps FFE adjustment necessary as seen from Kings Ln, looking north.</p> <p>Address: 64 Cottonwood Ln<br/>Corrales, NM 87048</p> | |

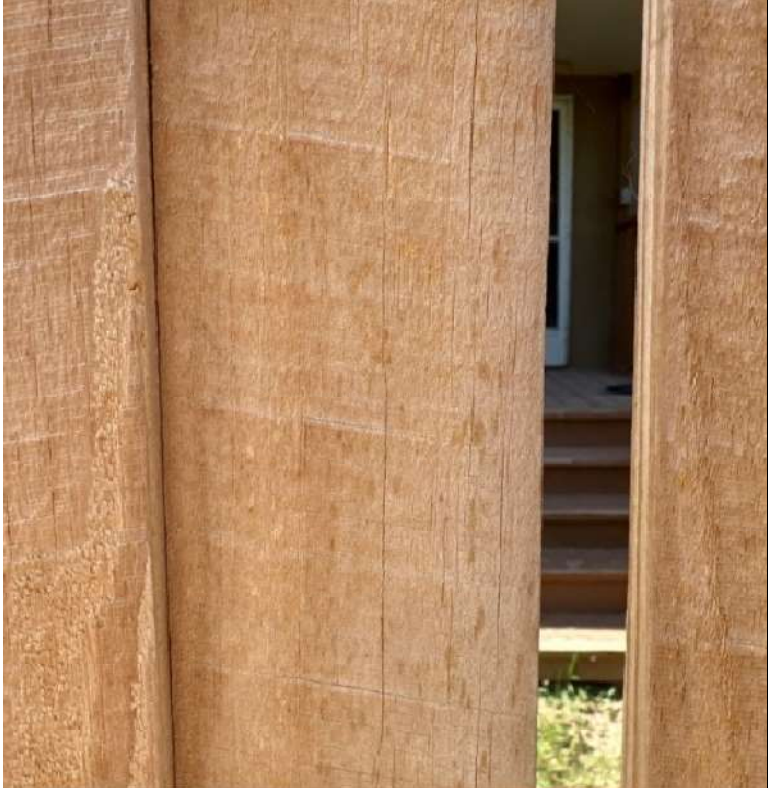
| <p>Location 15</p> <p>Lat: 35° 15' 16.37" N</p> <p>Long: 106° 36' 2.04" W</p> | <p>Name: Photo 34</p> <p>Feature Category: Building FFE Adjustment</p> <p>Description: Five (5) steps FFE adjustment necessary as seen from Kings Ln, looking south.</p> <p>Address: 86 Kings Ln Corrales, NM 87048</p> | |

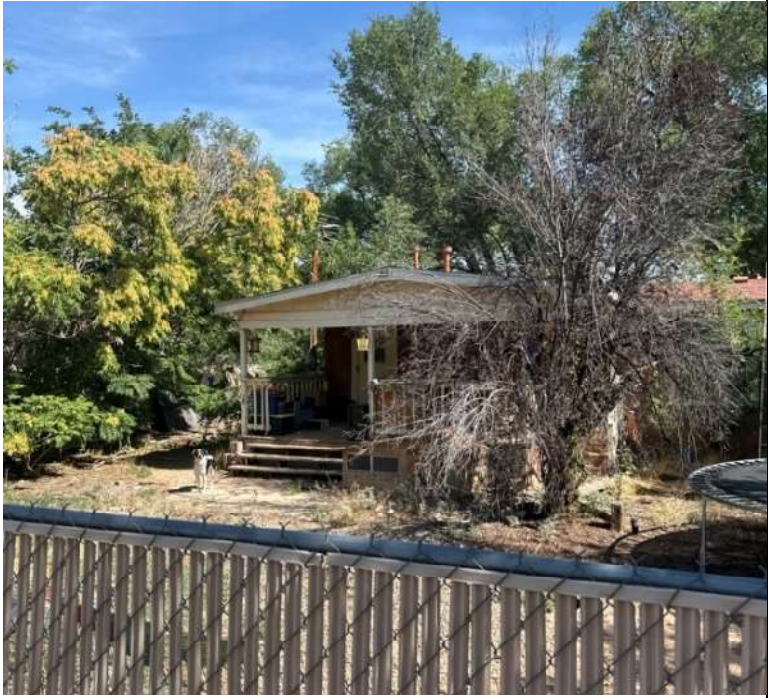
| <p>Location 16</p> <p>Lat: 35° 15' 16.61" N</p> <p>Long: 106° 36' 1.84" W</p> | <p>Name: Photo 35</p> <p>Feature Category: Building FFE Adjustment</p> <p>Description: Four (4) steps FFE adjustment necessary as seen from Cottonwood Ln, looking north.</p> <p>Address: 36 Cottonwood Ln Corrales, NM 87048</p> | |

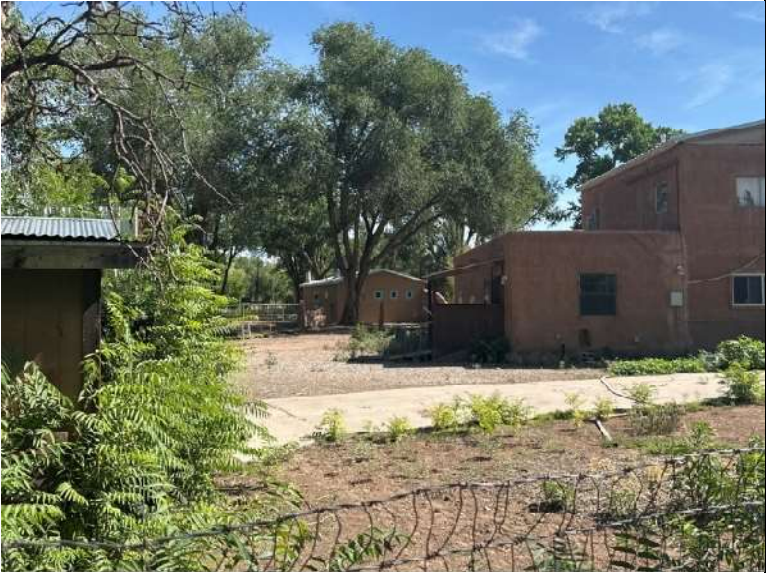
| <p>Location 16</p> <p>Lat: 35° 15' 16.61" N</p> <p>Long: 106° 36' 1.84" W</p> | <p>Name: Photo 36</p> <p>Feature Category: Building FFE Adjustment</p> <p>Description: Ramp FFE adjustment necessary as seen from Cottonwood Ln, looking north.</p> <p>Address: 9 Cottonwood Ln<br/>Corrales, NM 87048</p> | |

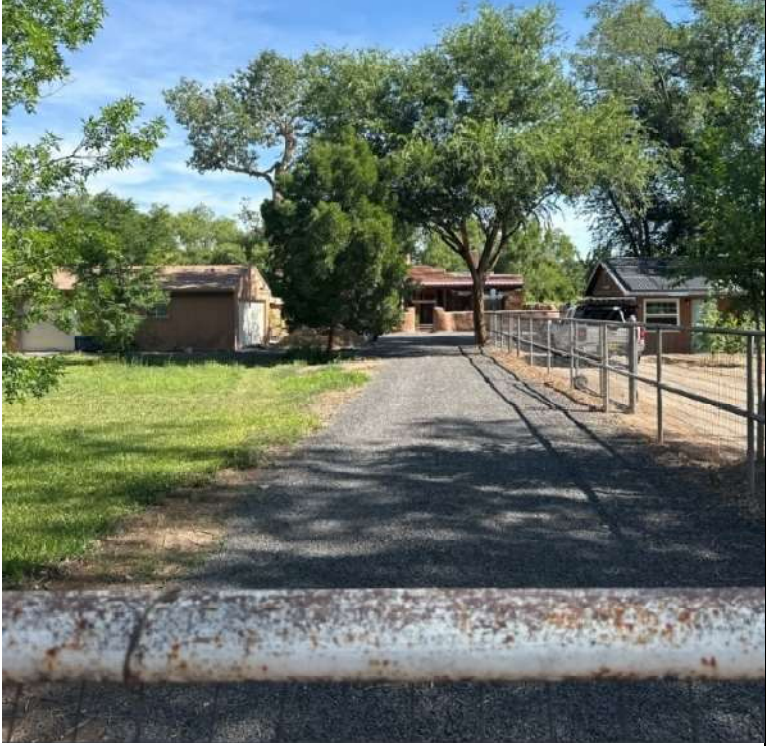
| <p>Location 19</p> <p>Lat: 35° 15' 18.06" N</p> <p>Long: 106° 36' 1.7" W</p> | <p>Name: Photo 39</p> <p>Feature Category: Building FFE Adjustment</p> <p>Description: No FFE adjustment necessary as seen from Cottonwood Ln, looking north.</p> <p>Address: 35 Cottonwood Ln<br/>Corrales, NM 87048</p> | |

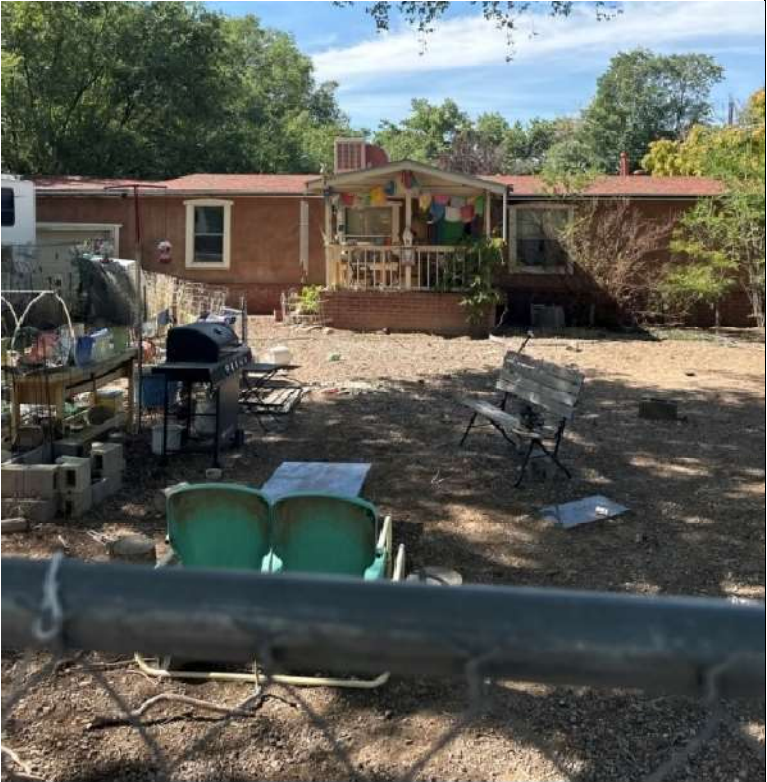
| <p>Location 20</p> <p>Lat: 35° 15' 18.0" N</p> <p>Long: 106° 36' 2.13" W</p> | <p>Name: Photo 40</p> <p>Feature Category: Building FFE Adjustment</p> <p>Description: Four (4) steps FFE adjustment necessary as seen from Cottonwood Ln, looking south.</p> <p>Address: 36 Cottonwood Ln Corrales, NM 87048</p> | |

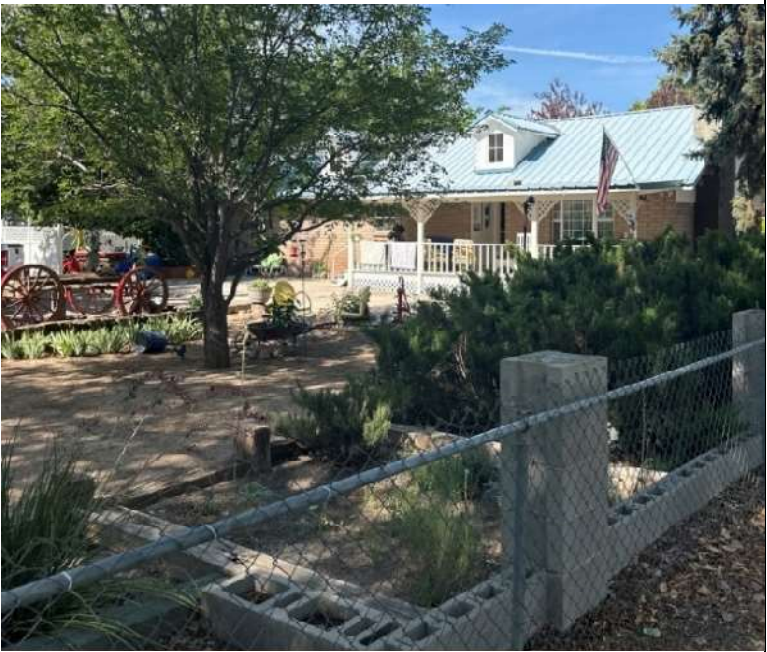
| <p>Location 21</p> <p>Lat: 35° 15' 17.97" N</p> <p>Long: 106° 36' 2.59" W</p> | <p>Name: Photo 41</p> <p>Feature Category: Building FFE Adjustment</p> <p>Description: Four (4) steps FFE adjustment necessary as seen from Cottonwood Ln, looking south.</p> <p>Address: 64 Cottonwood Ln Corrales, NM 87048</p> | |

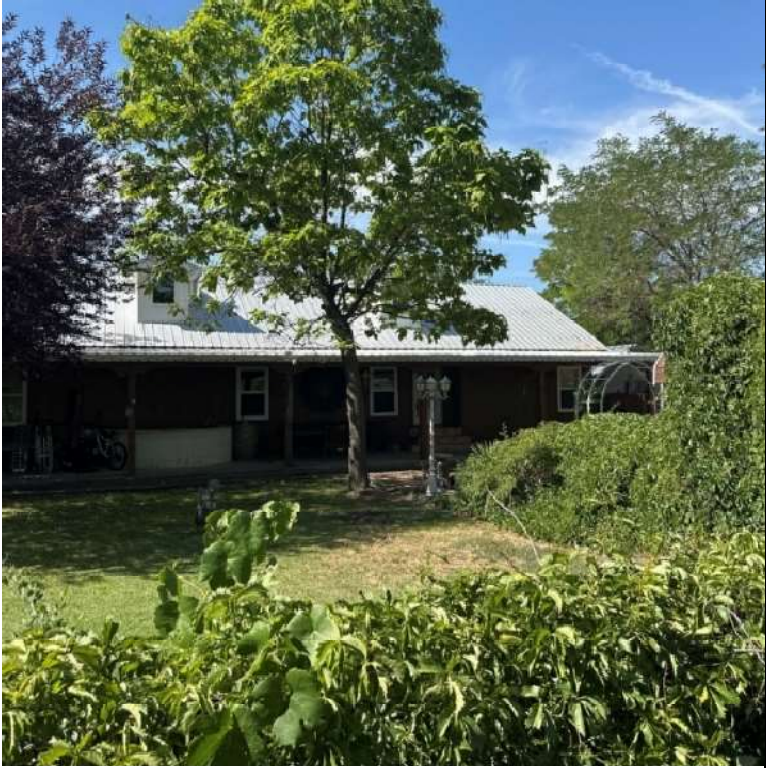
| <p>Location 22</p> <p>Lat: 35° 15' 17.93" N</p> <p>Long: 106° 36' 4.04" W</p> | <p>Name: Photo 42</p> <p>Feature Category: Building FFE Adjustment</p> <p>Description: Four (4) steps FFE adjustment necessary as seen from Cottonwood Ln, looking south.</p> <p>Address: 84 Cottonwood Ln Corrales, NM 87048</p> | |

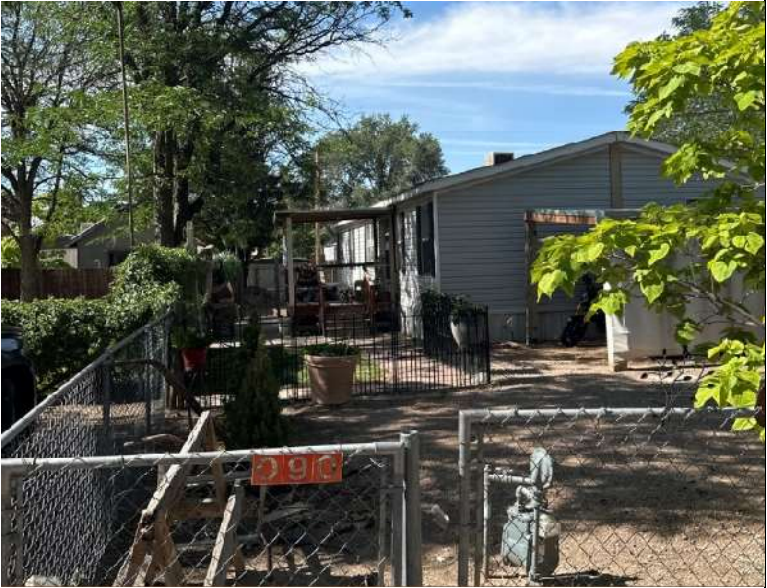
| <p>Location 23</p> <p>Lat: 35° 15' 17.94" N</p> <p>Long: 106° 36' 4.83" W</p> | <p>Name: Photo 43</p> <p>Feature Category: Building FFE Adjustment</p> <p>Description: Four (4) steps FFE adjustment necessary as seen from Cottonwood Ln, looking south.</p> <p>Address: 90 Cottonwood Ln Corrales, NM 87048</p> | |

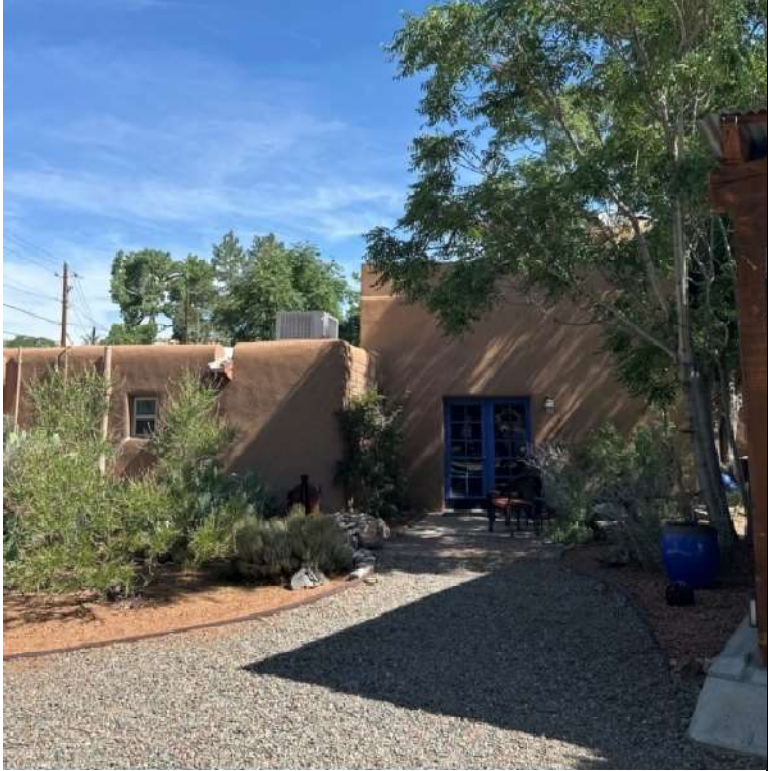
| <p>Location 24</p> <p>Lat: 35° 15' 21.63" N</p> <p>Long: 106° 35' 57.51" W</p> | <p>Name: Photo 44</p> <p>Feature Category: Building FFE Adjustment</p> <p>Description: Spoke to the owner. She has been here for 11 years and said part of the house is three steps down and part has a crawl space. She has experienced some heavy rains where her parking area flooded but the home has not flooded.</p> <p>Address: 6964 Corrales Rd Corrales, NM 87048</p> | A photograph of a single-story adobe house with a blue door, surrounded by desert landscaping and trees. The house is built with reddish-brown adobe walls. A blue door is visible on the right side of the house. The foreground is a gravel driveway. There are several trees and shrubs around the house, including a large tree on the right. The sky is blue with some clouds. |

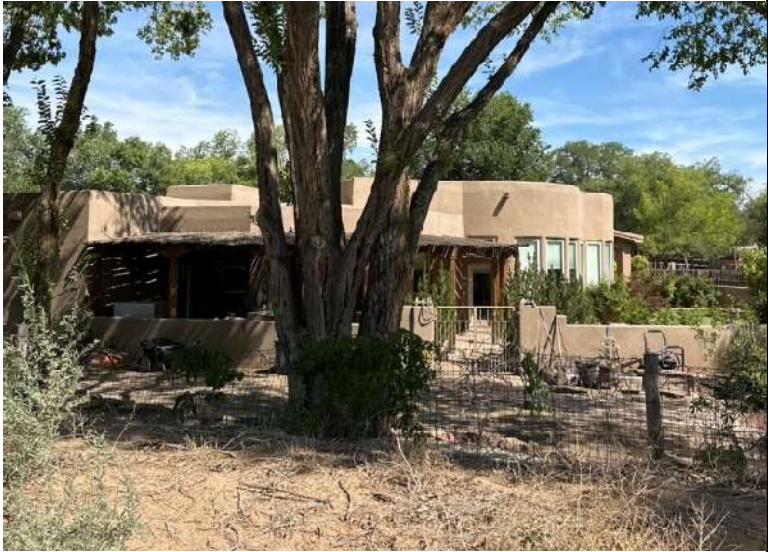
| <p>Location 25</p> <p>Lat: 35° 15' 21.29" N</p> <p>Long: 106° 36' 1.91" W</p> | <p>Name: Photo 45</p> <p>Feature Category: Building FFE Adjustment</p> <p>Description: Two (2) steps necessary as seen from northern Sandoval Lateral overbank, looking north.</p> <p>Address: 1 Stevie Ray's Way Corrales, NM 87048</p> | |

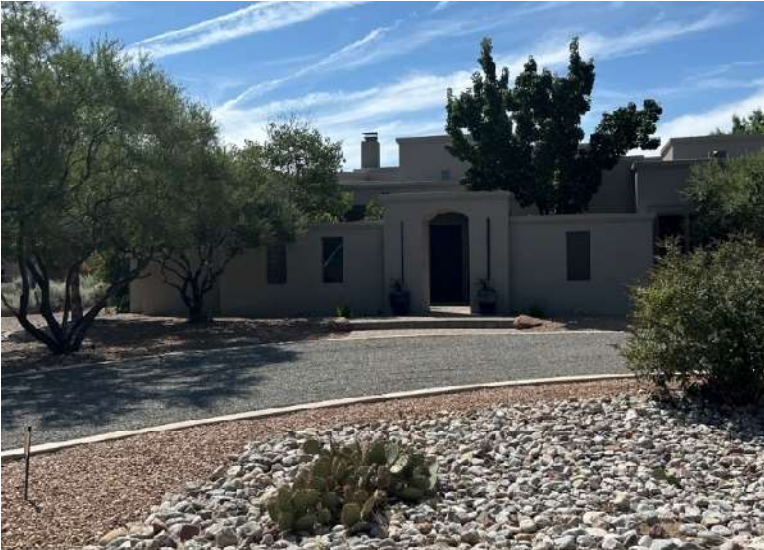
| <p>Location 27</p> <p>Lat: 35° 15' 22.24" N</p> <p>Long: 106° 36' 41.08" W</p> | <p>Name: Photo 47</p> <p>Feature Category: Building FFE Adjustment</p> <p>Description: One (1) step FFE adjustment necessary as seen from Jacob Ct, looking southeast.</p> <p>Address: 102 Jacob Ct Corrales, NM 87048</p> | |

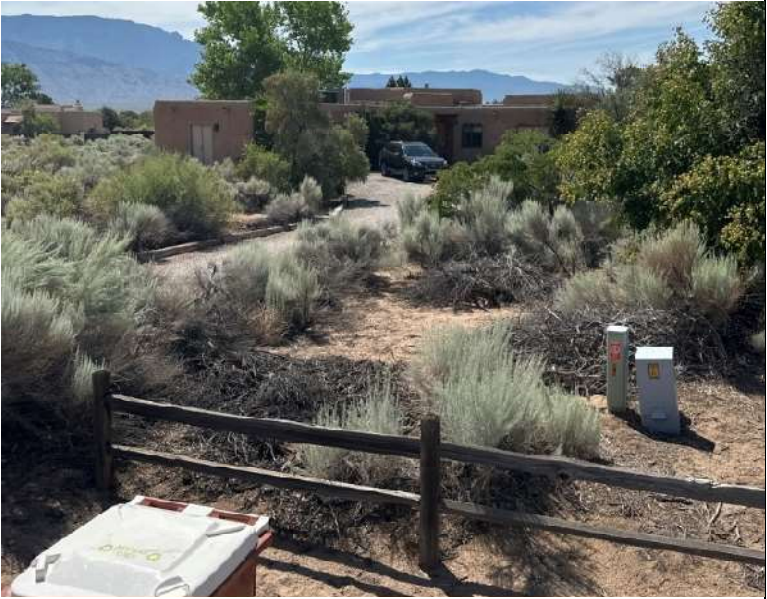
| <p>Location 28</p> <p>Lat: 35° 15' 22.82" N</p> <p>Long: 106° 36' 39.98" W</p> | <p>Name: Photo 48</p> <p>Feature Category: Building FFE Adjustment</p> <p>Description: One (1) step FFE adjustment necessary as seen from Jacob Ct, looking southeast.</p> <p>Address: 100 Jacob Ct Corrales, NM 87048</p> | |
