# Existing Conditions Hydraulic Analysis Report: Montoyas Arroyo, Harvey Jones Channel

**EXISTING CONDITIONS HYDRAULIC ANALYSIS REPORT FOR THE MONTOYAS ARROYO  
FROM THE HARVEY JONES CHANNEL INLET TO THE RIO GRANDE**

**SOUTHERN SANDOVAL COUNTY ARROYO FLOOD CONTROL AUTHORITY**

**BOHANNAN HUSTON, INC.**

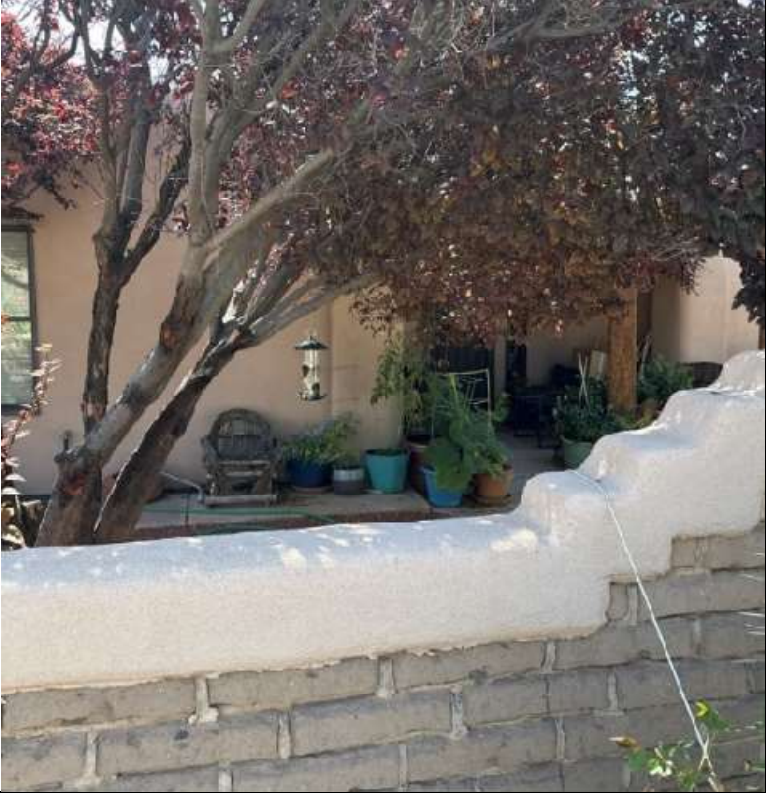
| <p>Location 30</p> <p>Lat: 35° 15' 18.53" N</p> <p>Long: 106° 36' 37.14" W</p> | <p>Name: Photo 51</p> <p>Feature Category: Building FFE Adjustment</p> <p>Description: One (1) step FFE adjustment necessary as seen from Carey Rd, looking southeast.</p> <p>Address: 129 Carey Rd Corrales, NM 87048</p> | |

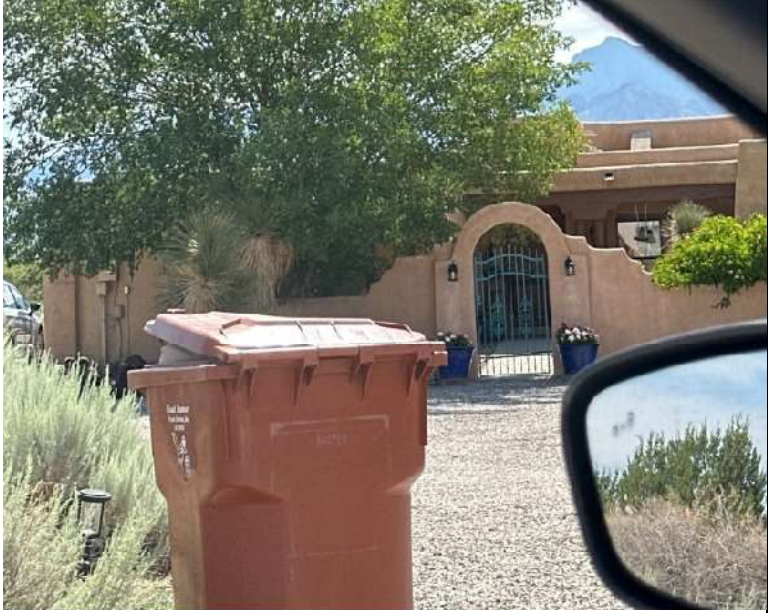
| <p>Location 31</p> <p>Lat: 35° 15' 18.48" N</p> <p>Long: 106° 36' 33.58" W</p> | <p>Name: Photo 52</p> <p>Feature Category: Building FFE Adjustment</p> <p>Description: One (1) step FFE adjustment necessary as seen from Carey Rd, looking east.</p> <p>Address: 136 Carey Rd Corrales, NM 87048</p> | |

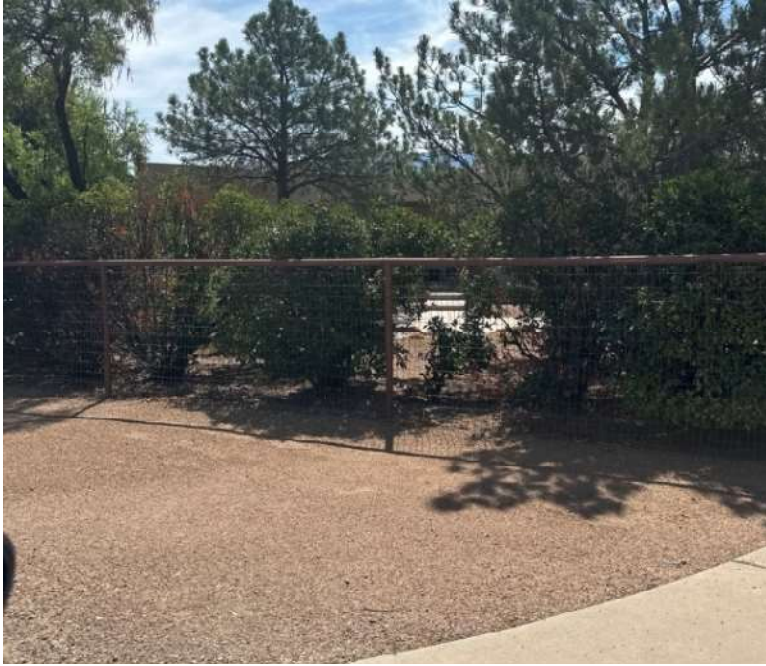
| <p>Location 33</p> <p>Lat: 35° 15' 14.84" N</p> <p>Long: 106° 36' 23.2" W</p> | <p>Name: Photo 54</p> <p>Feature Category: Building FFE Adjustment</p> <p>Description: Two (2) steps FFE adjustment necessary as seen from Doolittle Rd, looking east.</p> <p>Address: 122 Doolittle Rd Corrales, NM 87048</p> | |
