GEOTECHNICAL ENGINEERING SERVICES REPORT JOB NO. 1-10302

SOUTHERN SANDOVAL COUNTY ARROYO & FLOOD CONTROL AUTHORITY

HARLEY POND PROJECT

RIO RANCHO, NEW MEXICO

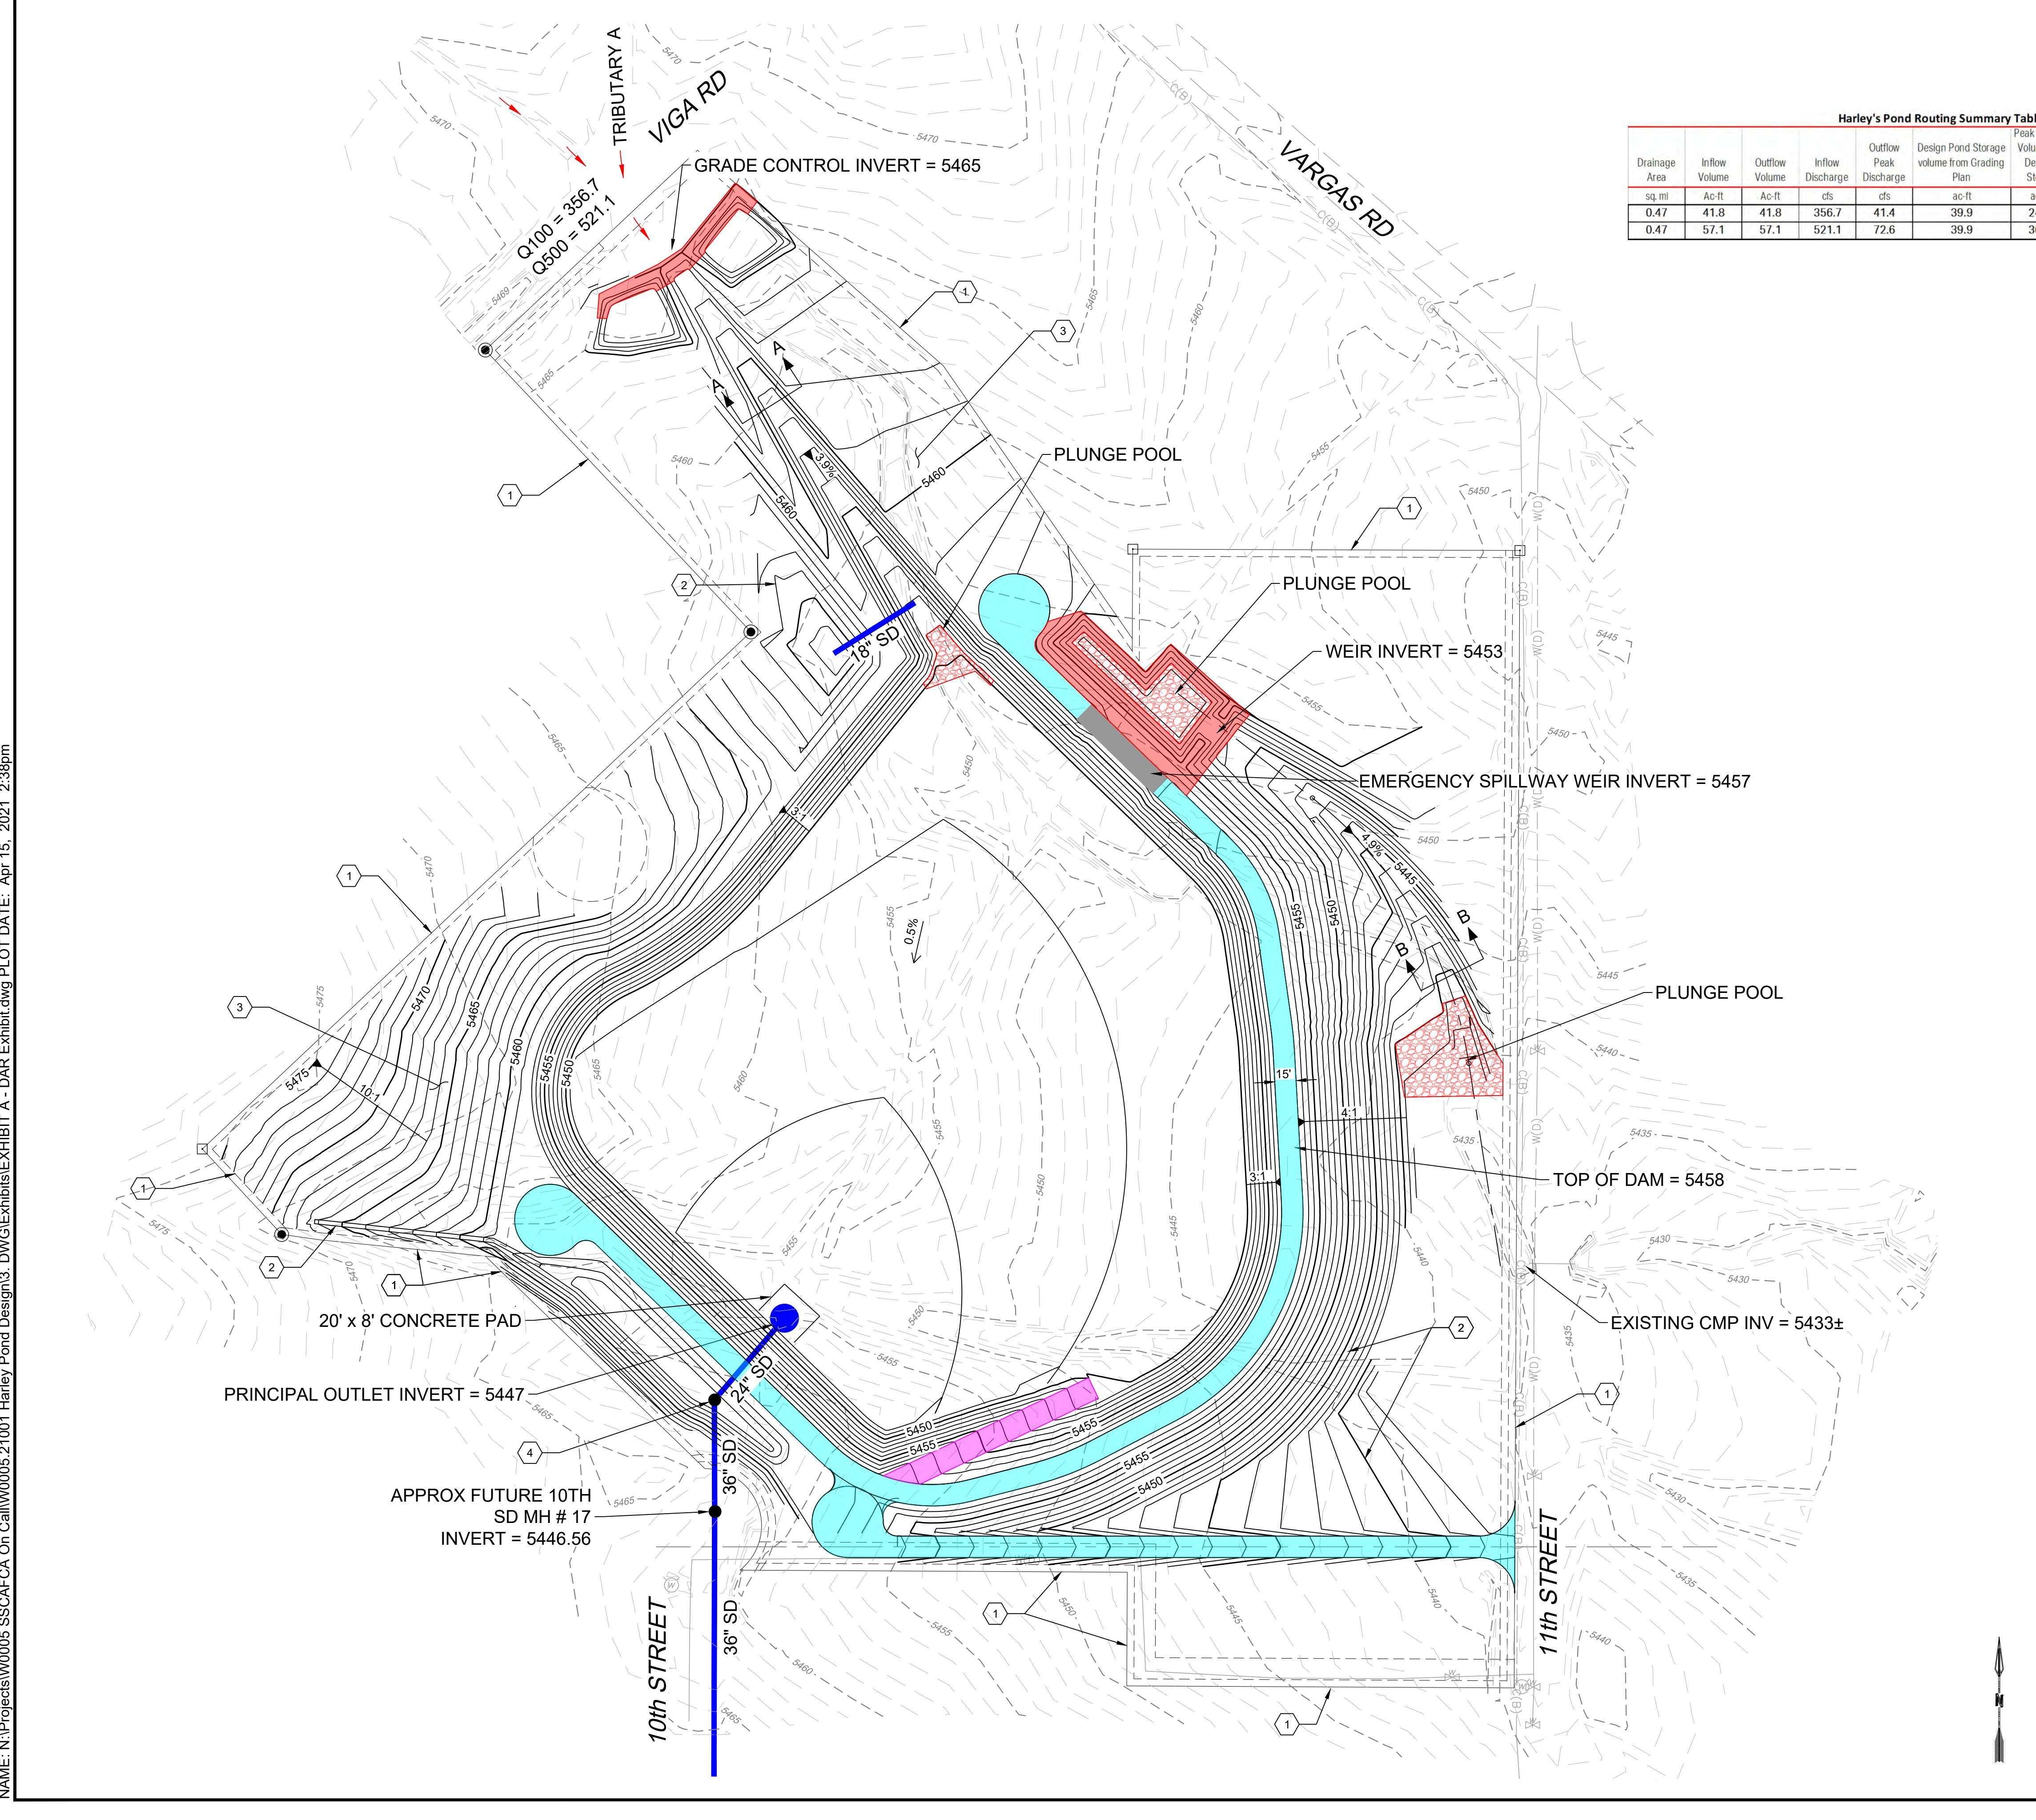
EXHIBIT A HARLEY'S POND CONCEPTUAL DESIGN

The primary outlet for the pond will be a drop inlet structure located on the southern side of the pond within the cut area. The drop inlet will feed into reinforced concrete pipes connected to the city storm sewer system. An emergency spillway weir will be constructed on the northern portion of the pond with an associated concrete lined channel. The inlet to the pond will be a concrete lined channel at the approximate location of an existing arroyo located at the northern portion of the pond. A conceptual site plan is included as Figure 1 in a later section of this report.
