# Arroyo de la Barranca Watershed Park Management Plan

August 2022

Southern Sandoval County  
Arroyo Flood Control Authority  
(SSCAFCA)

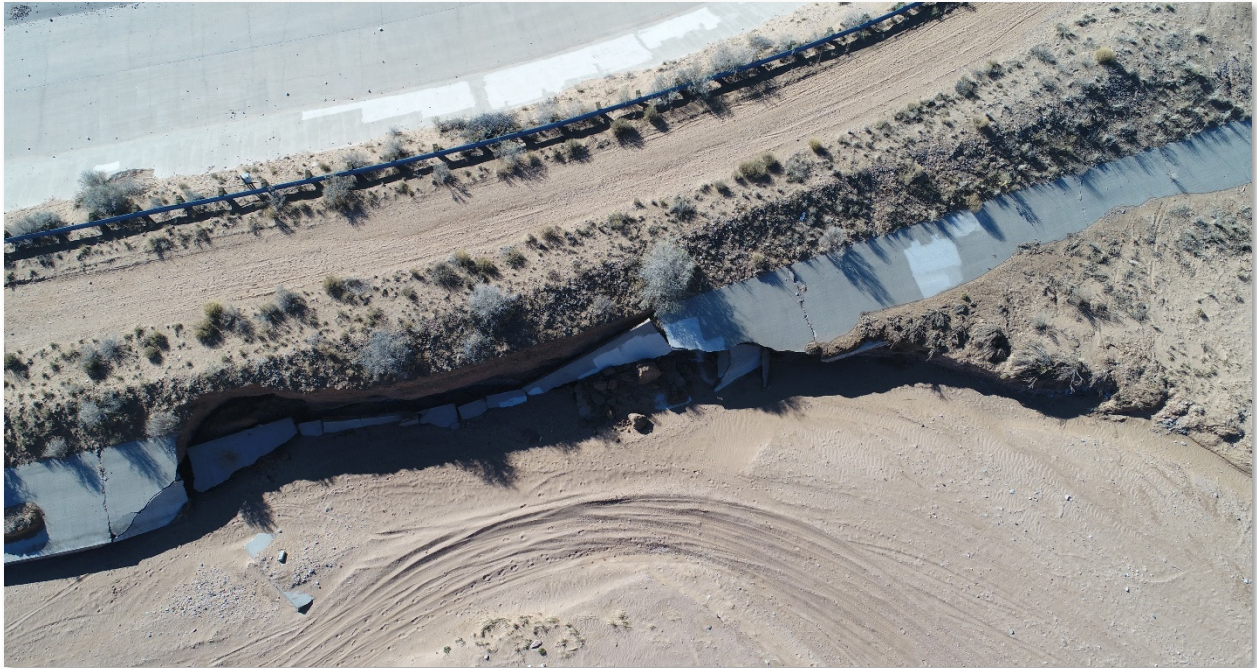
As part of the water quality structure design, realignment of the concrete channel conveying flows from Tributary B to the Barranca Arroyo is proposed (see Figure 3.5). Existing bank protection along the north side of the channel is failing due to undercutting of the concrete by flows in the main stem of the Barranca Arroyo (Figure 3.6). Realignment of the channel would

divert flows into the proposed water quality pond and remedy the erosion issue, with the added benefit that flows from Tributary B would also be treated before reaching the Rio Grande.

**Figure 3.6: Failing bank protection in the lower Barranca Arroyo.**
